Landsliding on the south east coast of the Isle of Wight: nature, characteristics and causes

Cole, G. (2013) 'Landsliding on the south east coast of the Isle of Wight: nature, characteristics and causes', *The Plymouth Student Scientist*, 6(2), p. 124-176.

Grant Cole

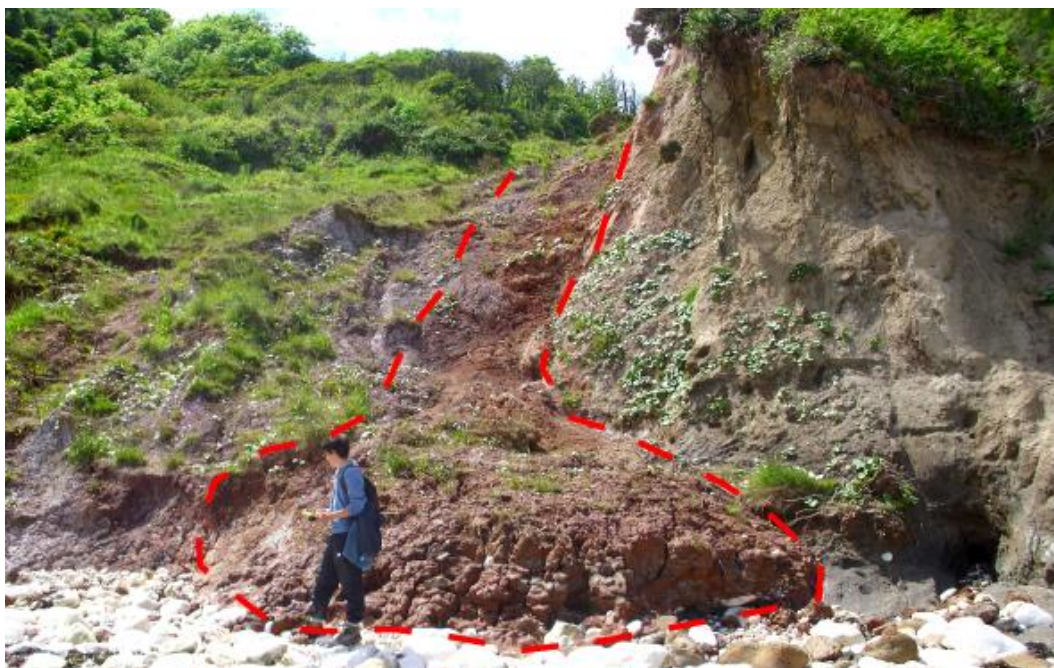
Figure 3.2 Flow type landslide (6) in Whitecliff Bay (south), person for scale.

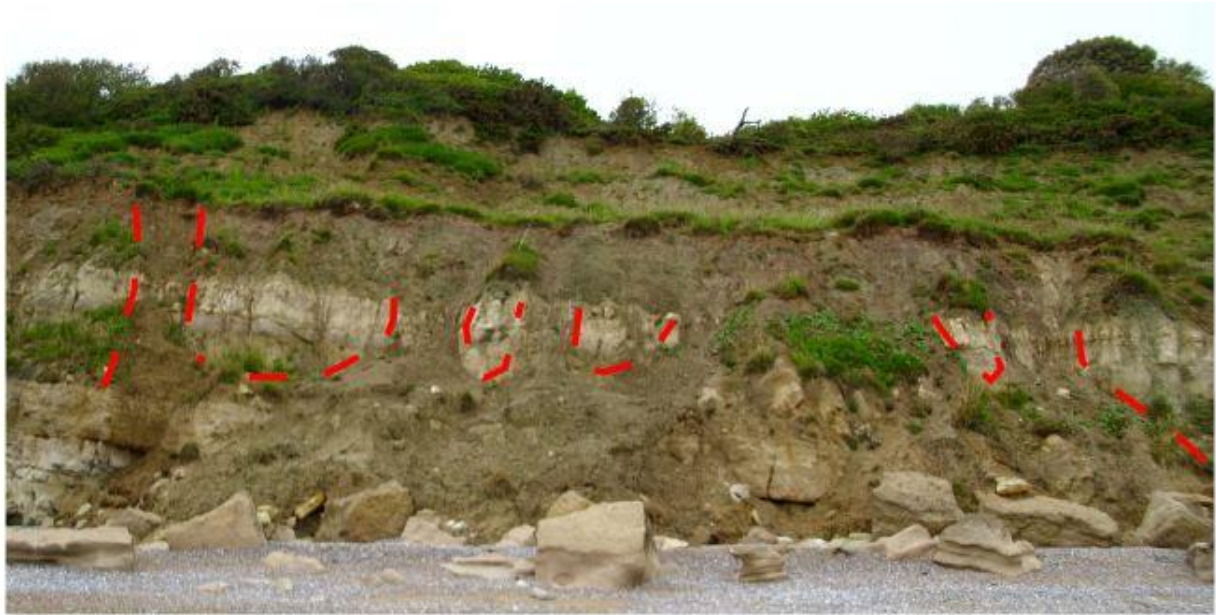
Figure 3.3 Complex landslide with main type of movement (25) being flow type (Whitecliff Bay).

The Fall type landslides seen at Culver Down (Whitecliff) (Figure 3.1 & photo 3, Figure 3.12) show an accumulation of rocks at the base of the cliff / slope, which can vary in size (see landslide inventory; appendix C). The flow type landslides in Whitecliff Bay have a typical channel shape to them which then expands at the front in a lobate structure (Figure 3.2). Complex landslides with flow as the main movement types are similar but due to there being many converging flows the lobate form is lost for this particular landslide (Figure 3.3).

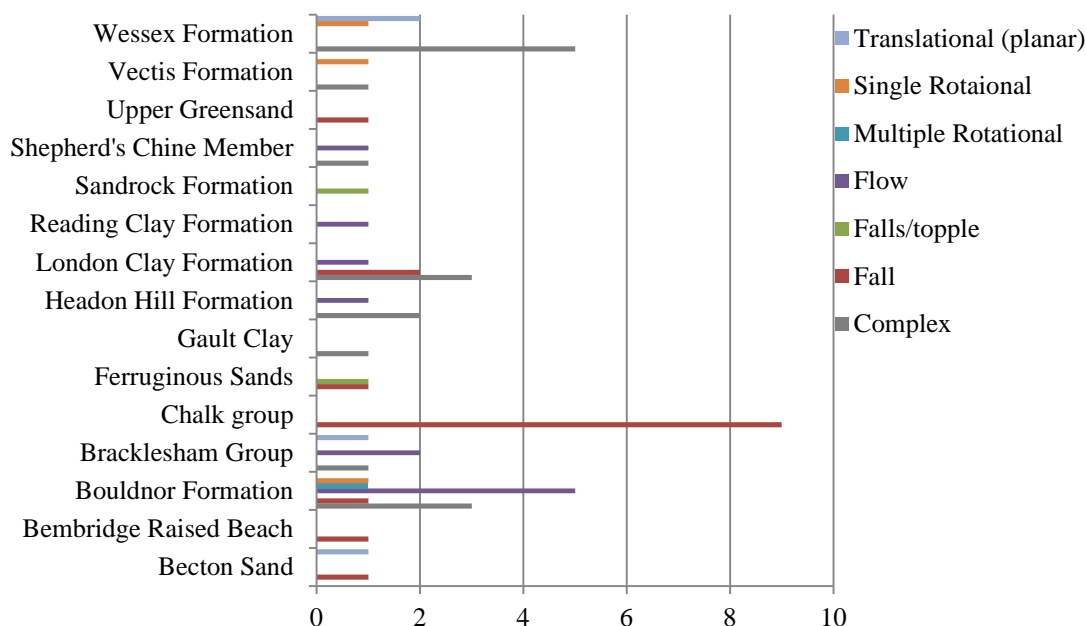
Figure 3.13 The relationship between chronostratigraphy and landslide type for landslides involving a single chronostratigraphic unit.

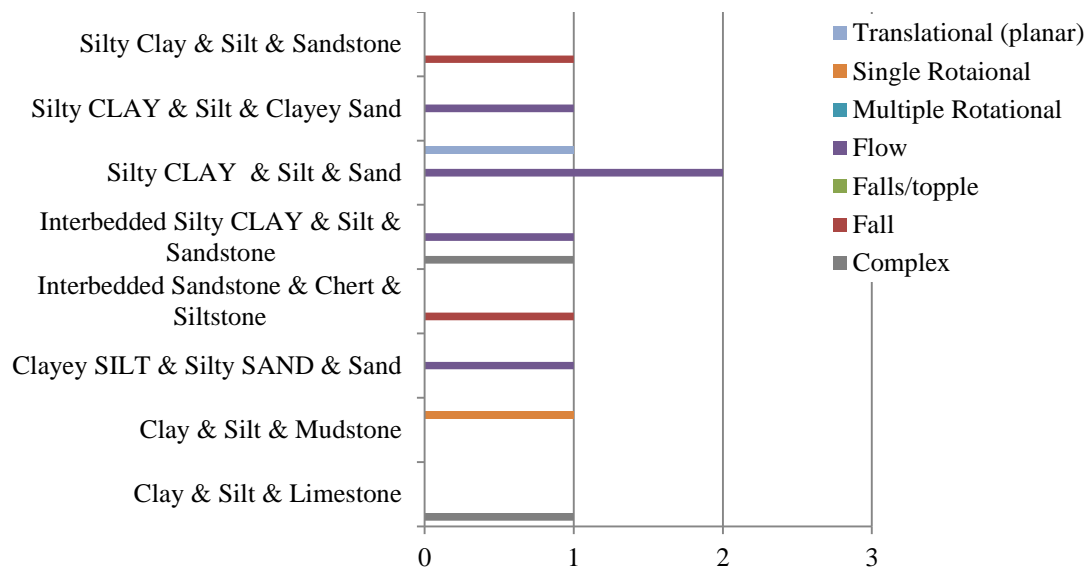
Figure 3.17 The relationship between movement type and lithology for landslides involving three lithologies.

landslide involved lithified material with Chalk being the most common (Figure 3.15-3.17).
