Flexural behaviour of BFRP rebar reinforced concrete beams

The Plymouth Student Scientist

Edgaras Rudžinskis

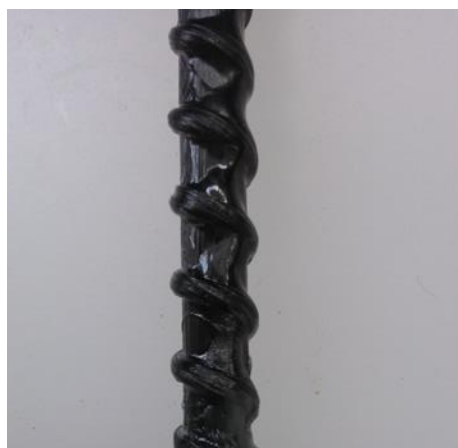
Figure 1: Basalt Fibre Reinforced Polymer rebar.

Basalt is a naturally occurring volcanic rock that originates from frozen lava that can be found in abundance in the Earth's crust. Basalt Fibre Reinforced Polymer (BFRP) rebar is formed by crushing basalt rock into a powder which is then heated to melting point (approximately 1450 degrees Celsius). A fine nozzle is then used to extrude the molten material to form a thin continuous strand. These strands are bundled and bound together by using a polymeric compound, to produce long straight rebars. Often supplementary BFRP strands are used to form spiral ribbing, by winding them transversely around the rebar, to provide containment and rigidity to the rebar and increase the strength of the mechanical anchorage between the concrete and rebar (Gohnert, Gool & Benjamin, 2014). Figure 1 demonstrates the finished product of BFRP rebar.

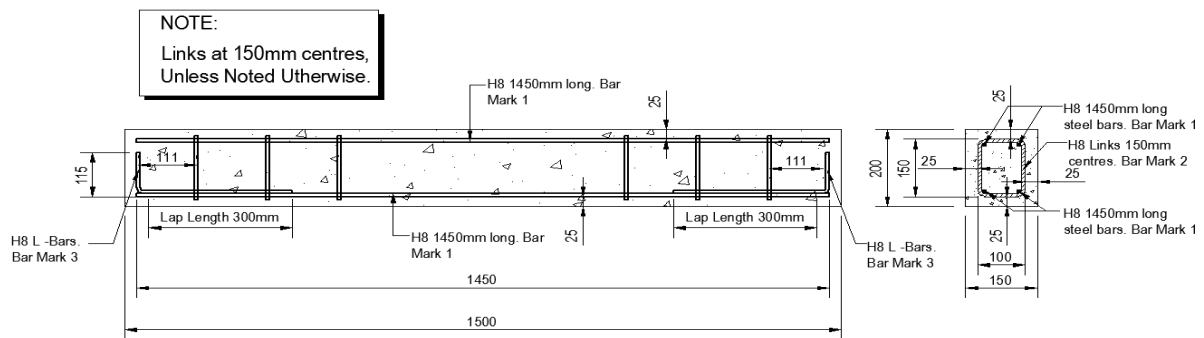
Figure 2: Reinforcement Setting-Out.3

Four reinforced concrete beams (150mm wide, 200mm deep and 1500mm long), containing different reinforcing setups as indicated in Figure 2 were used. Due to constraints in the laboratory, the reinforcement cover was reduced to be 25mm. The diameter of the BFRP and steel rebar element sizes that were used in this experimental study are both 8mm. The information regarding the reinforcement setting-out, sizes and element length are outlined in Figure 2 and in the bar bending schedule

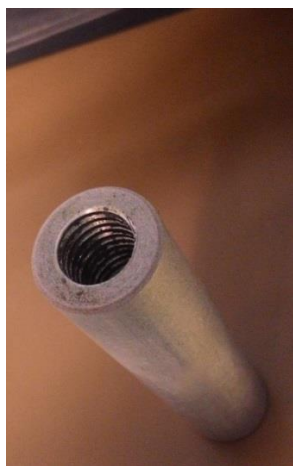
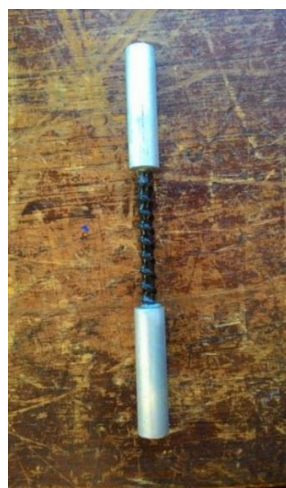
Photo 1: BFRP rebar encased in threaded aluminium rods.

Both ends of the BFRP rebar sample were encased in the aluminium rods that were threaded inside, as illustrated in Photo 1.

During the second attempt to increase the surface grip area, two aluminium rods were attached to each end of the basalt rebar sample. Holes with a 10mm diameter were drilled and the inside faces of the walls of the aluminium rods were threaded to increase the mechanical key between the BFRP rebar and the aluminium rod. Subsequently each end of the basalt rebar sample was placed inside the aluminium rods and set with resin and adhesive. During the tensile testing stage the basalt rebar pulled out of the aluminium rods before it reached its maximum tensile capacity. It was concluded that failure occurred due to the resin shear resistance being significantly smaller than the tension force applied by the testing machine (refer to **Error! Reference source not found.** in appendix **Error! Reference source not found.**). Gohnert, Gool & Benjamin (2014) claimed that by encasing both ends in tight fitting tubes, the maximum tensile capacity of BFRP rebar was achieved. Therefore, it is arguable that Gohnert, Gool & Benjamin (2014) in his study used specifically high shear resistance resin when undertaking tensile tests. In addition to that, when visually inspecting aluminium rods it was observed that they did not deform. Thus, this suggest that the aluminium rod wall could be too thick and therefore did not transfer the “grip” to the BFRP rebar (refer to **Photo 1**).

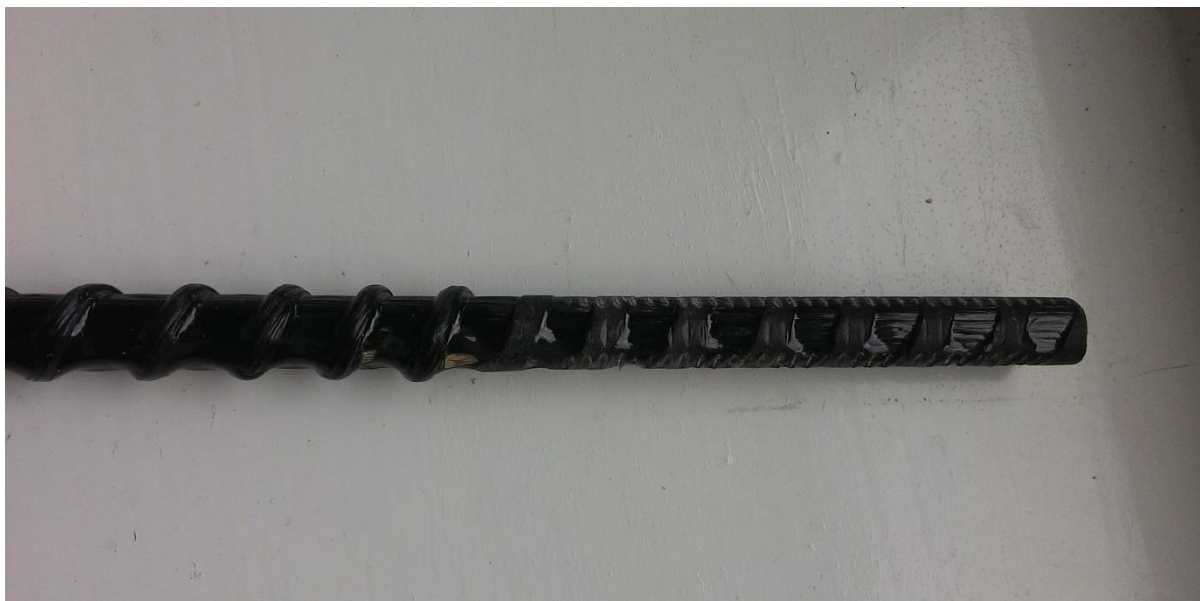
Photo 2: Ends of BFRP Rebar Sanded Off.

Both ends of the BFRP rebar sample had 50mm of the BFRP spiral sanded off the overall length (refer to Photo 2).

Moreover, it was attempted to “sand off” the BFRP spiral at each end as illustrated in **Photo 2**. Once again the experiment failed to test BFRP rebar maximum tensile capacity as one end of the rebar came out of the testing machine clamps. During the visual inspection, it was observed that the “teeth” of the upper clamp were partly damaged. **Error! Reference source not found.** attached in appendix **Error! Reference source not found.** illustrates the damaged “teeth” condition. Additionally, when the smaller size clamps were used, the failure of the test was caused by the BFRP rebar sample crushing inside the clamps (refer to **Error! Reference source not found.** attached in appendix **Error! Reference source not found.**). Due to brittle nature of fibre binding resin, it was not able to withstand the force in the lateral direction.

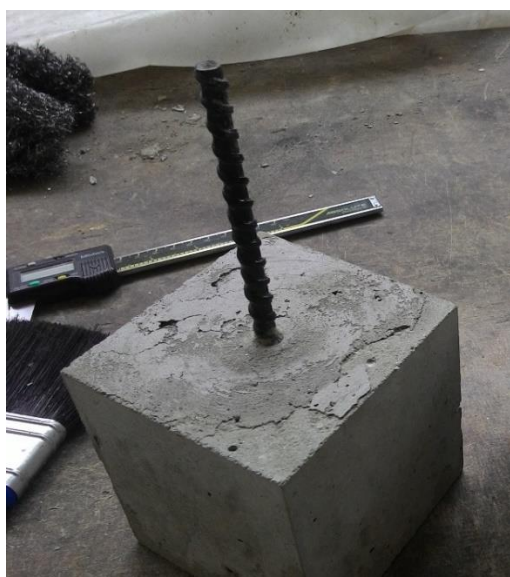
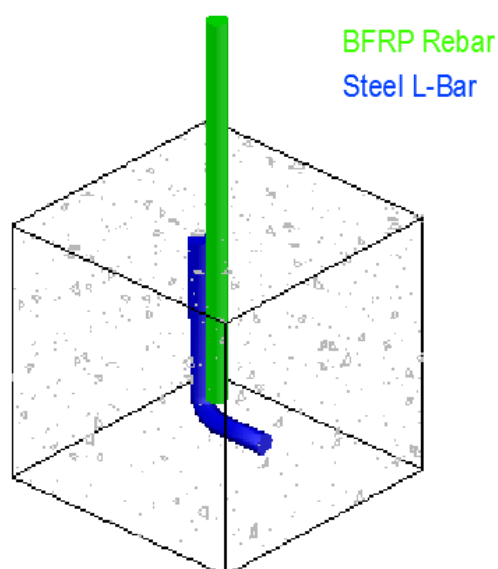
Photo 3: BFRP Rebar Encased Concrete Cube.

The BFRP rebar lapped with steel L bar and encased in class40/50 concrete cube (100 mm x 100 mm x 100 mm). A concrete cube mix was designed to ensure that compression failure does not occur before BFRP rebar tensile capacity is reached. Refer to appendix **Error! Reference source not found.** for the concrete mix design.

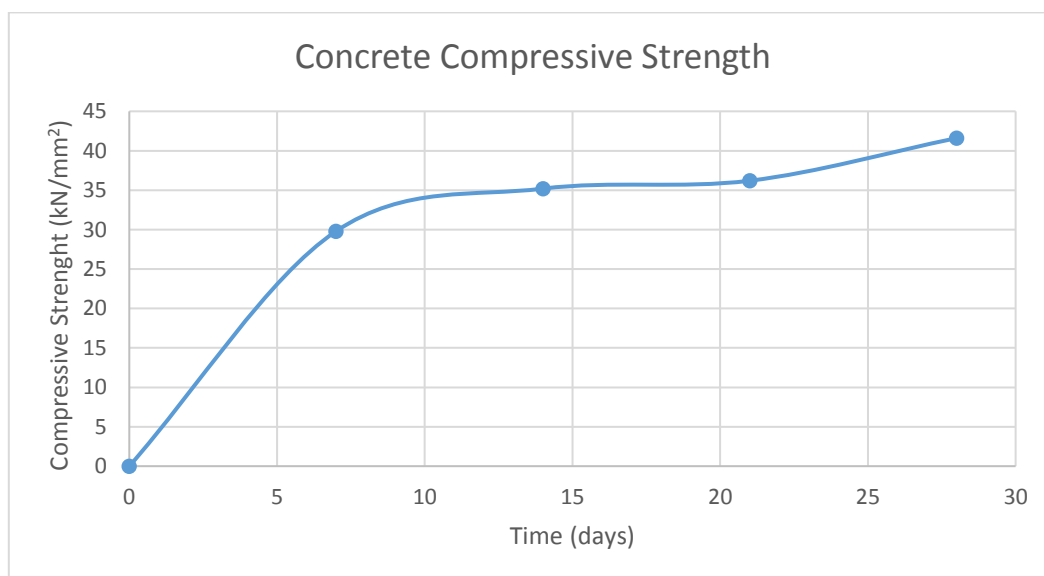
Graph 1:Concrete Compressive Strength Progression.

Appropriate personal protective equipment (PPE) was used including protective goggles, rubber gloves, a dusk mask and a laboratory coat. Further to that, based on the manufacturer’s COSHH assessment form, no additional PPE has been required during handling of the BFRP rebar. The COSHH assessment form regarding the BFRP rebar is attached to the appendix **Error! Reference source not found.**. Multiple cube samples were cast during the reinforced concrete beams casting stages to determine compressive strength of the beam when tested. Cubes were placed in the water chamber for controlled curing purposes (refer to appendix **Error! Reference source not found.**). Additionally, the progression of compressive strength was closely monitored and the concrete cubes were tested at 7, 14, 21 and 28-day periods. Further to that, compression tests were carried out on the same day each reinforced concrete beam was tested. Graph 1 depicts the compressive strength progression of class C28/35 concrete.

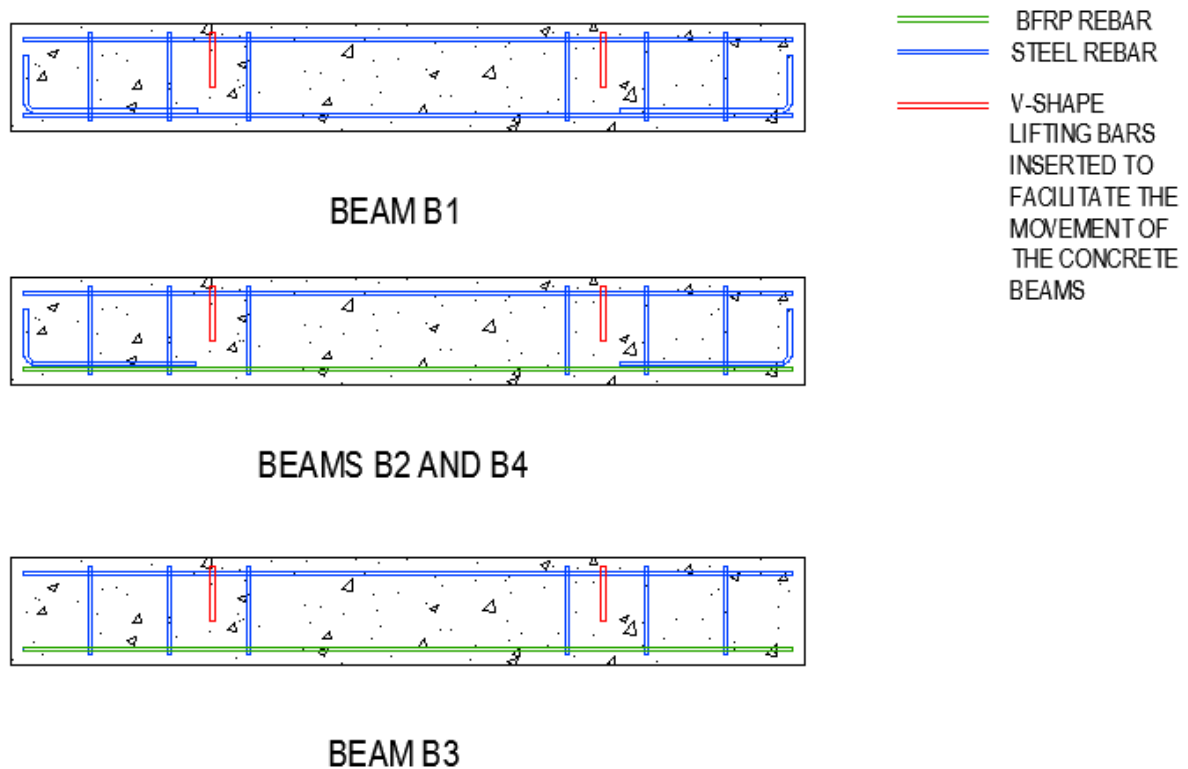
Figure 3: Reinforcement General Layout.

Research into existing BFRP Rebar manufacturers determined that the manufacturer “Vulkan” based in Denmark would sponsor the project by supplying the required BFRP rebar. Four reinforcing cages were assembled with the following features: Cage 1 consisted entirely of steel elements such as top and bottom longitudinal bars, shear links (omitted in the middle region) and L bars. Cages 2 and 4 contained the same steel elements except for the bottom (tension zone) reinforcement, which was substituted with the BFRP rebar. Cage 3 contained the same elements as Cages 2 and 4 except that the L bars were removed. Figure 3 illustrates the different reinforcement setups. Further to that, photos regarding basalt and steel reinforcement setups are attached in appendix **Error! Reference source not found.** Moreover, to facilitate the in-situ casting procedure, appropriate moulds were assembled and all four beams were cast. Photo 4 illustrates the types of moulds that were assembled.

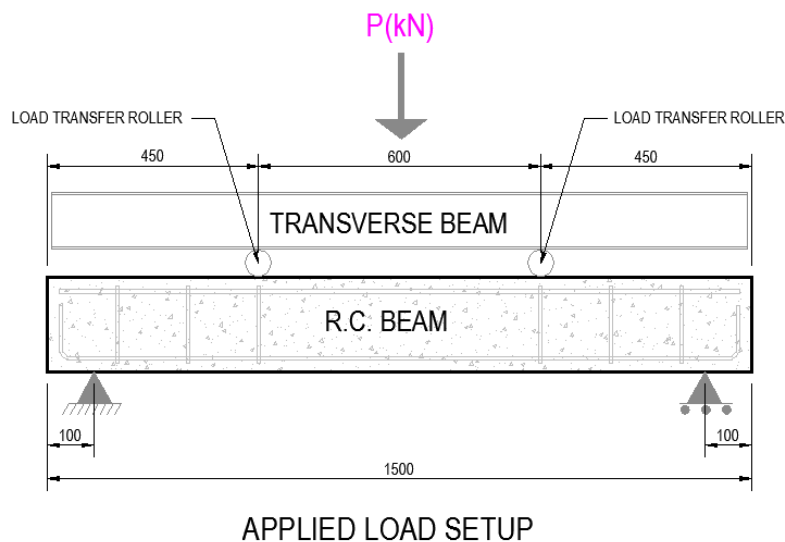
Figure 4: Four Point Load Setup

The load was carried by the beams in the four-point system consisting of the steel transverse beam which transfers applied external load to the middle region of the reinforced concrete (R.C.) beam (refer to Figure 4). The transverse steel beam self-weight is approximately 1.3kN which was included in further analysis of the beam test results. To ensure that localized failure at the concrete beam surface due to load transfer rollers did not occur, body filler was applied between the R.C. beam surface and load transfer roller (see Photo 5) which acted as a “cushion” during the beam test.

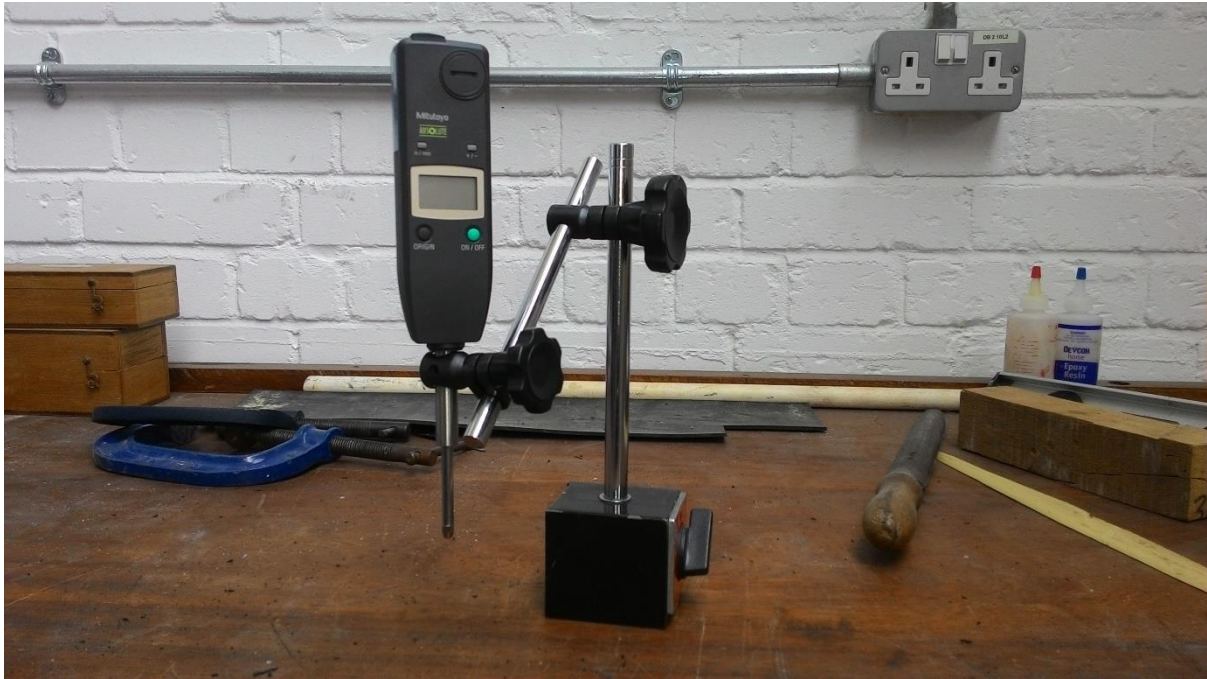
Photo 6: External Vertical Displacement Gauge.

The external vertical displacement gauge was used due to an initial disposition of the experimental load application machinery in the Heavy Structures laboratory. The gauge was applied during the un-cracked section testing phase. The gauge was placed at the mid-span of the under-side of each concrete beam (refer to appendix **Error! Reference source not found.**). During the cracked section testing stage, the external displacement gauge was removed from its original position to prevent the gauge being damaged if brittle concrete beam failure occurred. External deflection readings were used to determine the percentage difference between predicted and experimental deflection of un-cracked section concrete beams.

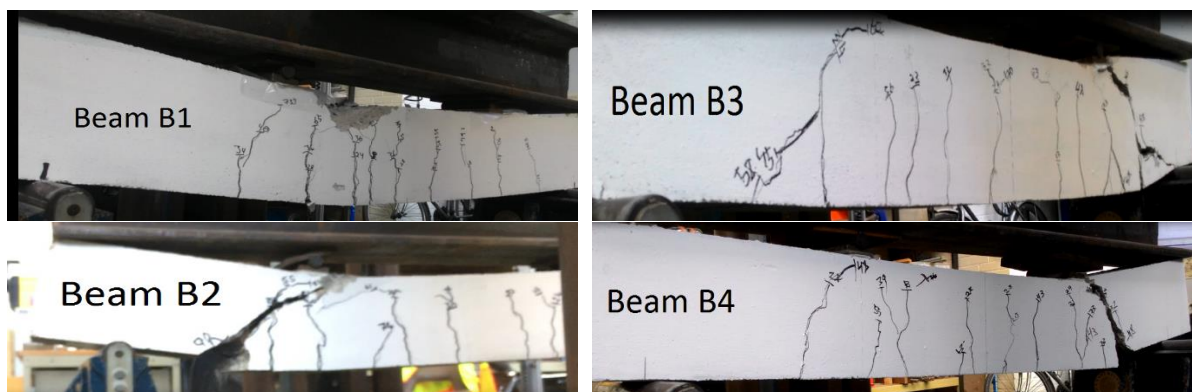
Photo 6: Failure Modes of Each Beam.

Flexural behaviour experiments revealed that crack propagation characteristics were similar for all four beams. Photo 6 shows that vertical cracks propagated in the middle region of the beams, followed by diagonal cracks located closer towards the supports. The first crack appeared during the application of an external load of 20 kN. More detailed crack propagation under increasing loading is illustrated in appendix **Error! Reference source not found.** The reinforced concrete beams' failure types are discussed in section 6.4.

Photo 6 also illustrates the failure mode of each beam. The observed failure modes suggest that the beam reinforced with 100% traditional steel reinforcement (Beam B1) failed in compression with concrete spalling from the top of the section which is the compression zone. On the other hand, the concrete beams reinforced with basalt longitudinal bars located at the bottom (Beams B2, B3 and B4) experienced failure which can be described as “shear failure”.

Ultimately, it is important to note that shear failure in BFRP rebar reinforced concrete beams occurred at one end only (refer to **Photo 6**). This could be caused by marginally different reinforcement position at each end of the beam. It is possible that reinforcement could have dislocated from its original position during the beam casting stage when a vibrating poker was used. In addition, that marginal difference in shear link spacing, during the reinforcement cage assembly phase could have contributed to the unsymmetrical reinforcement setup. Furthermore, the analysis carried out suggests, that the shear span of the tested beams was 1.8, as depicted in Figure 7. This suggests that the shear span ration was too low and potentially resulted in shear failure BFRP rebar reinforced beams as illustrated in Photo 6. Naik & Kute (2014) suggested that, that to prevent shear failure, shear span to depth ratio should be greater than 2.5.

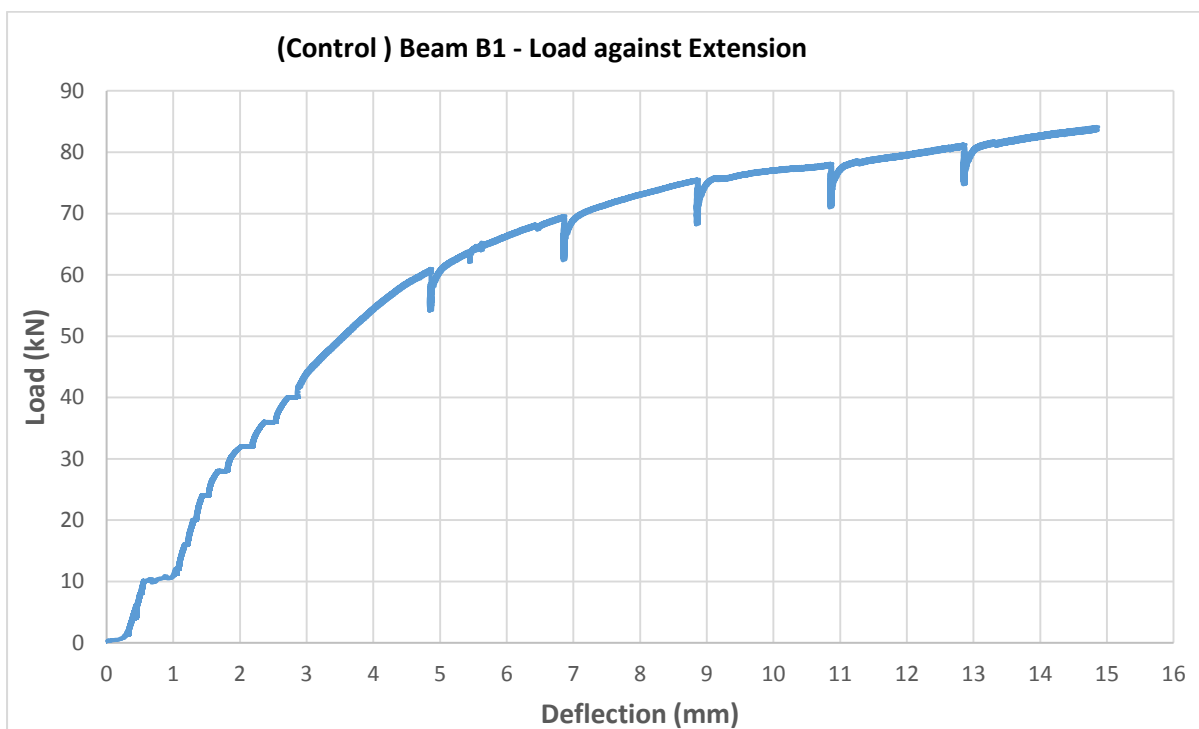
Graph 2: Beam B1: Load against Extension.

Firstly, the ultimate load capacity in kilo-Newtons (kN) was determined using ultimate load capacity principles calculated in appendix **Error! Reference source not found..** Subsequently, a flexure test of the reinforced concrete beam with 100% steel reinforcement was carried out. It is important to note that this beam was used as a control beam for comparison and analysis is outlined in further sections. The control beam flexure test showed that failure occurred at a maximum load of 84.13kN (including the self-weight of the transverse beam) with the corresponding deflection of 14.8mm as indicated in the Graph 2.

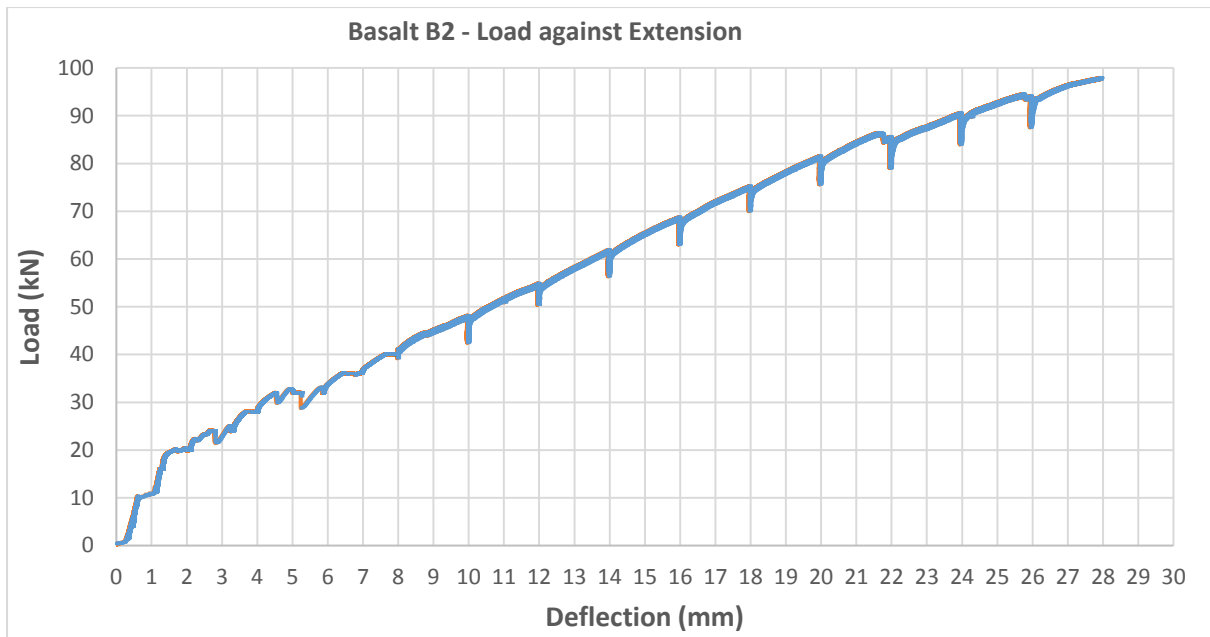
Graph 3: Beam B2: Load against Extension.

The results depicted in Graph 3 correspond to the flexure test of the reinforced concrete beam with basalt longitudinal bars located at the bottom (tension zone) and lapped with steel L bars at each end (refer to Figure 4). The maximum load achieved including the self-weight of the transverse beam was 97.9kN with a corresponding deflection of 27.927mm.

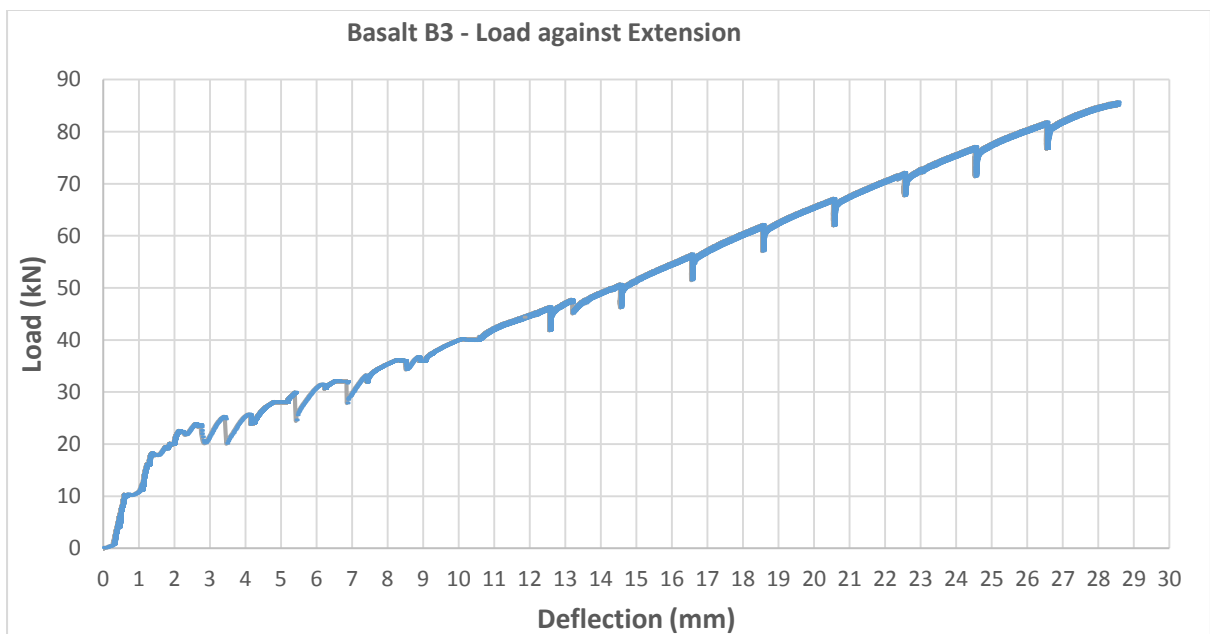
Graph 4: Beam B3: Load against Extension.

The experiment showed that beam 3 reached a maximum load of 85.642 kN (including the self-weight of transverse steel beam) with a corresponding deflection of 28.5mm. Graph 4 depicts B3 concrete beam's behaviour when subjected to load under flexure.

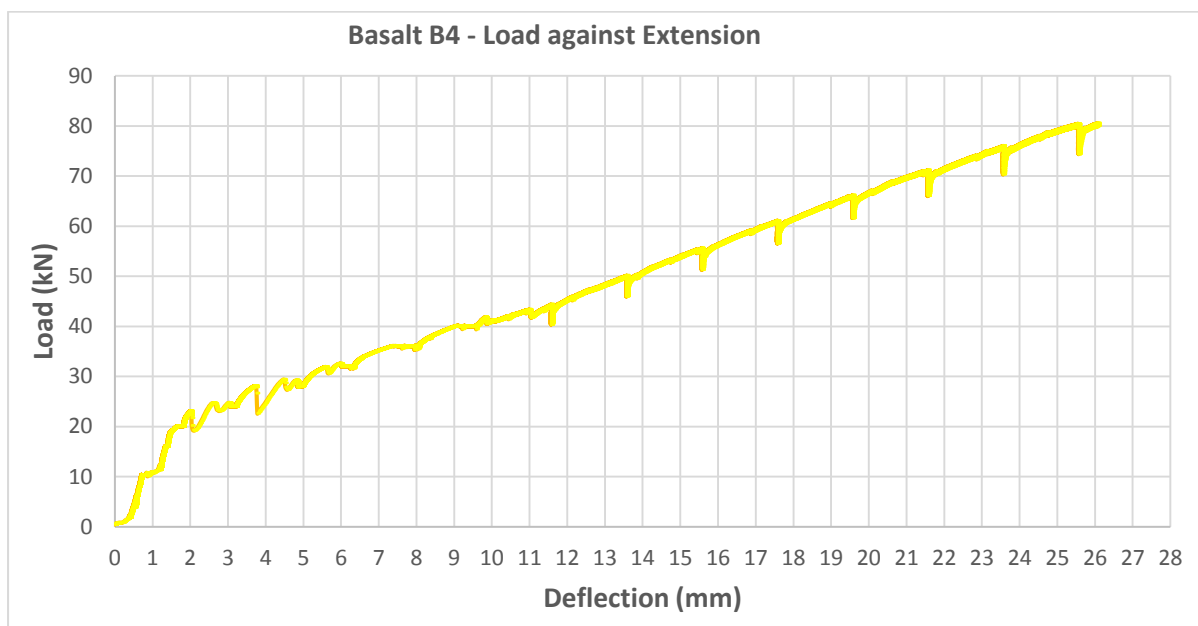
Graph 5: Beam B4: Load against Extension.

It was found that beam 4 reached a maximum load of 80.549kN (including the self-weight of the steel transverse beam) with a corresponding deflection of 26.1mm. Graph 5 depicts concrete beam B4’s behaviour when subjected to load under flexure.

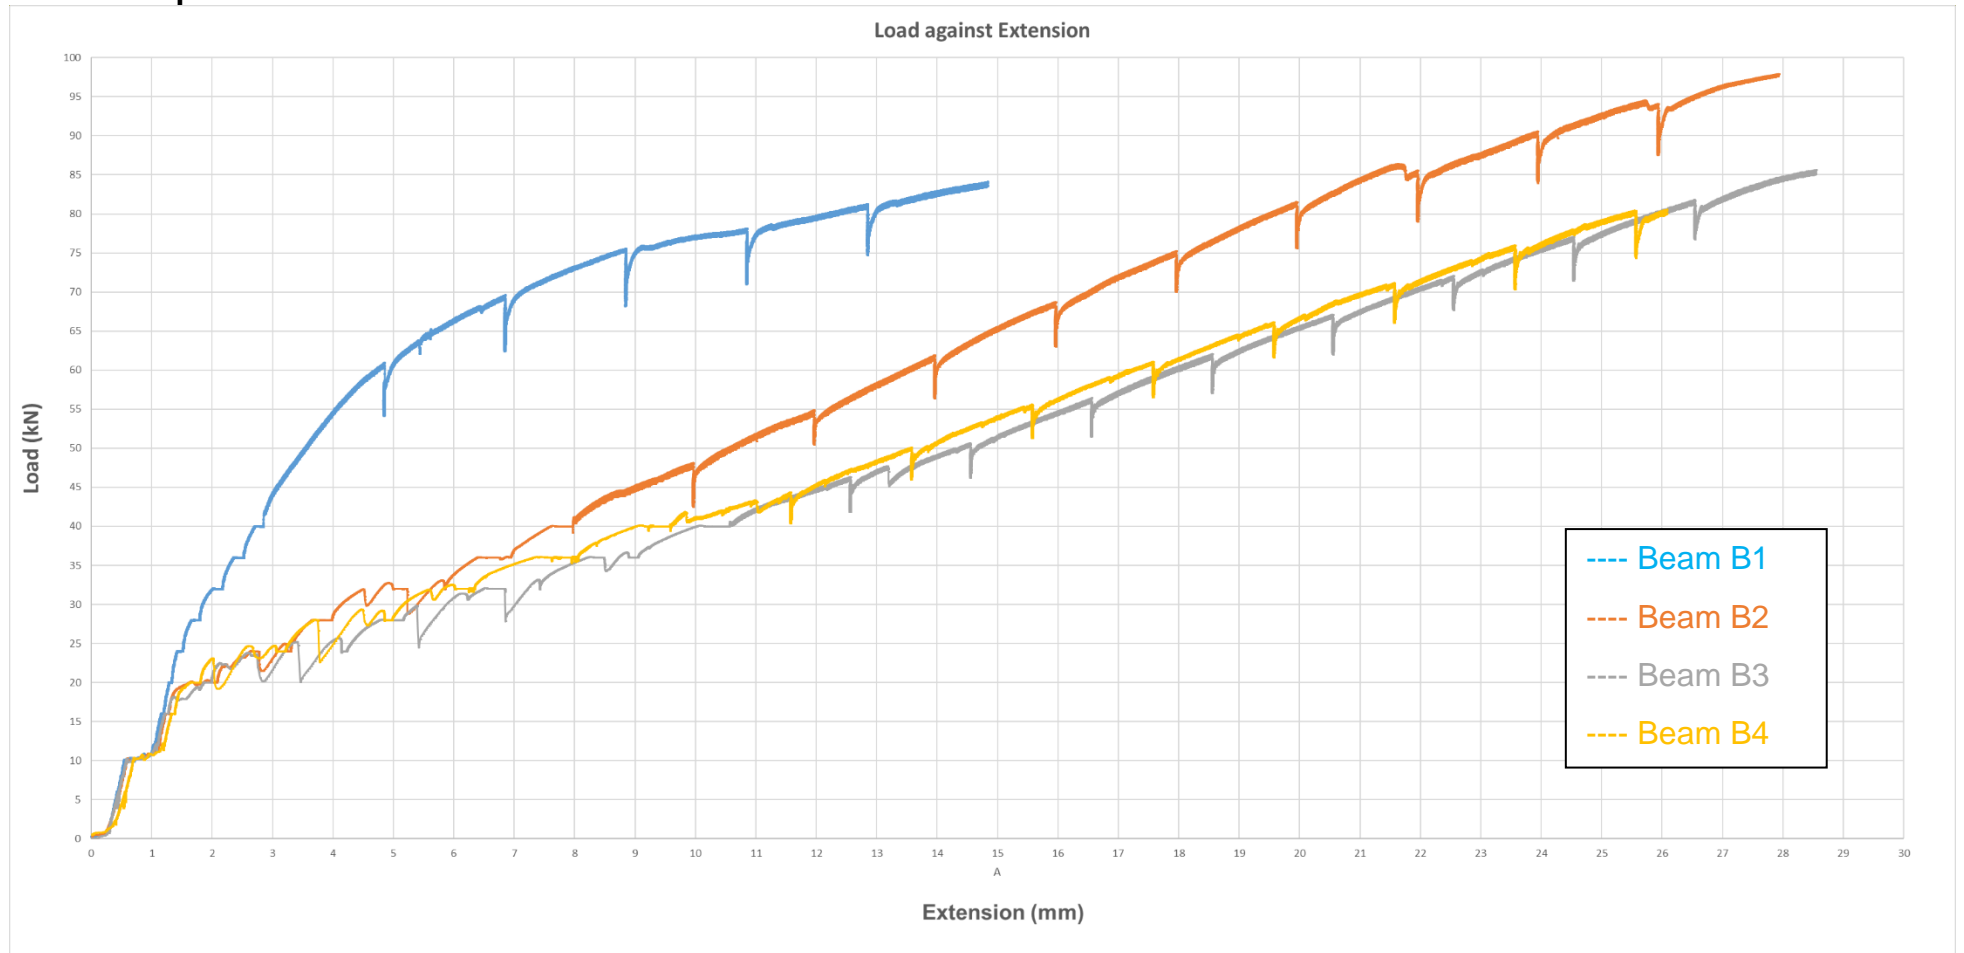
Graph 6: Comparison of All Four Beams: Load against Extension.

Furthermore, Graph 6 summarises the load and deflection relationship obtained by the reinforced concrete beam tests.

It is evident from Graph 6 that concrete beam concrete mix has been consistent since the initial gradient of load- deflection graphs up to around 20kN are almost identical. This suggests that the BFRP rebar reinforced un-cracked section concrete beams behaved virtually identical to traditional steel reinforced concrete beam when the section was un-cracked.

In contrast, it can be clearly seen that once the BFRP rebar reinforced beams are cracked, the behaviour in terms of load and displacement is fundamentally different. It appears from Graph 6 that the relationship between the cracked section load and displacement of the BFRP rebar reinforced concrete beams (B2, B3 and B4) is virtually linear, whereas the traditional steel reinforced concrete beam (B1) has a clearly visible yielding stage. This can be explained by the low value of BFRP rebar modulus of elasticity (refer to appendix **Error! Reference source not found.**), which is over 4 times lower than traditional steel rebar. Additionally, linear load and deflection relationship suggests that failure load should be easily predictable as opposed to the steel yielding stage.

Furthermore, there is a relatively small variation between the cracked section concrete beams reinforced with BFRP rebar as depicted in Graph 6. The ultimate load at which the beams failed varies from 5.9% to 21.5% within the 3 BFRP rebar reinforced concrete beams and the displacement variation ranges between 2.0% and 8.4%. Nevertheless, based on the previously outlined percentage variation, the suggestion can be made that a materials factor should be introduced when designing reinforced concrete beams reinforced with BFRP rebar to account for the ultimate load and displacement variations.

Moreover, Graph 6 shows that BFRP rebar reinforced concrete beam B3 with free ends (no anchor) exhibited greater maximum deflection at failure compared with the other two concrete beams which are BFRP rebar reinforced and lapped with steel L bars. Current experimental data obtained suggests that anchoring of BFRP tension rebar reduces maximum deflection. On the other hand, although beam B3 displayed the highest vertical displacement at failure, the corresponding failure load was higher than beam B4 but lower than beam B2. In order to support the hypothesis that anchoring BFRP tension rebar reduces the deflection, more samples beams must to be tested in order to provide more credible and robust results. In addition to that, beam B4 lower ultimate failure load being lower than beam B3 could be dictated by the BFRP tension bars being damaged by the steel L bars, observed during the visual inspection (refer to section 6.4.4).

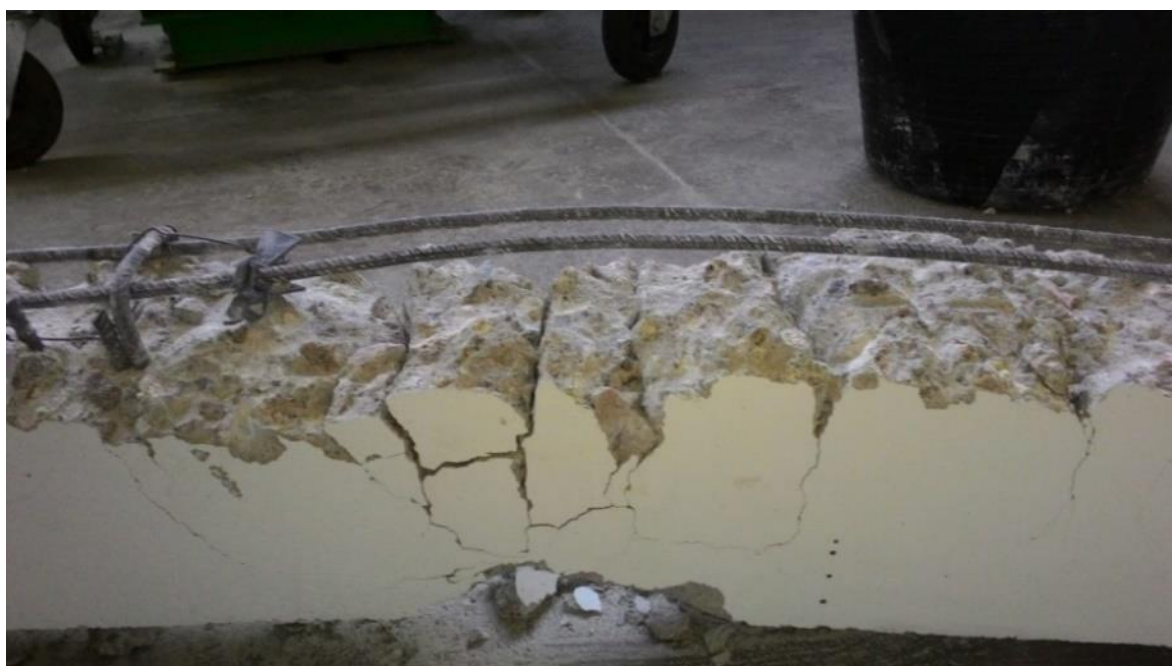
Photo 7: Beam B1 Yielded Tension Steel Bars.

Concrete removal from the bottom face of the concrete beam reinforced using 100% steel reinforcement, showed that no significant slippage occurred. Further to that, bar yielding was clearly visible. Photo 7 illustrates the appearance of tension in the longitudinal steel rebar after undergoing a yielding stage.

Beam bending tests showed that the concrete beam (B1) reinforced with 100% traditional steel reinforcement (refer to Figure 4), experienced compression failure as illustrated in Photo 6. This can be explained by the fact that once the concrete beam cracks, the neutral axis shifts higher towards the top of the concrete beam section. As this progresses further, the top area withstanding compression generated by the external load, reduces until the concrete’s compressive strength becomes lower than compressive force generated on to the beam by application of an external load. This causes concrete to spall from the top of the concrete beam and the beam to fail. Figure 6 depicts the compression area reduction in reinforced concrete beam. Furthermore, the compression failure (refer to Photo 6) occurred prior to steel bottom tension bar “snapping”. (refer to Photo 7).

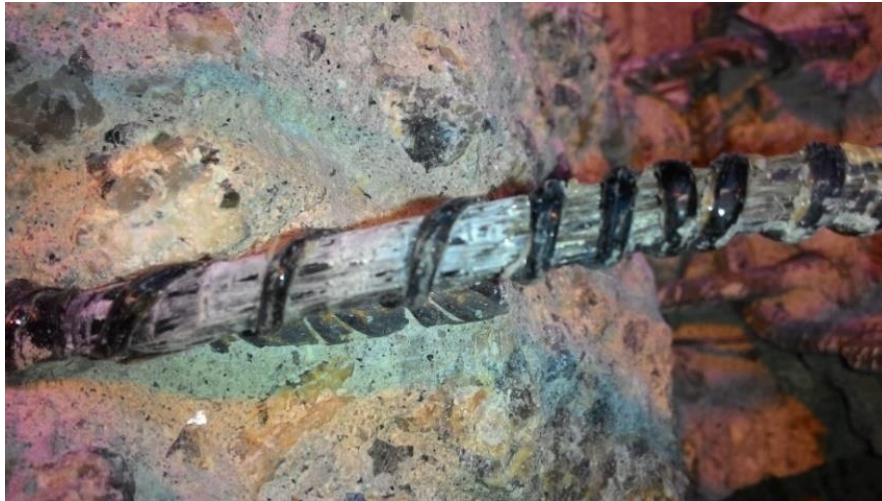
Photo 8:Basalt B2: basalt spiral strands are debonding from longitudinal strands.

After the completion of the beam testing stage, the concrete was removed from the top and bottom faces of the concrete beams to carry out a visual inspection and investigate the slippage phenomenon. Firstly, it was observed that the basalt rebar experienced debonding of the spiral strands which act as ribs to increase the mechanical key between basalt rebar and concrete. Photo 8 illustrates the observed basalt rebar debonding phenomenon.

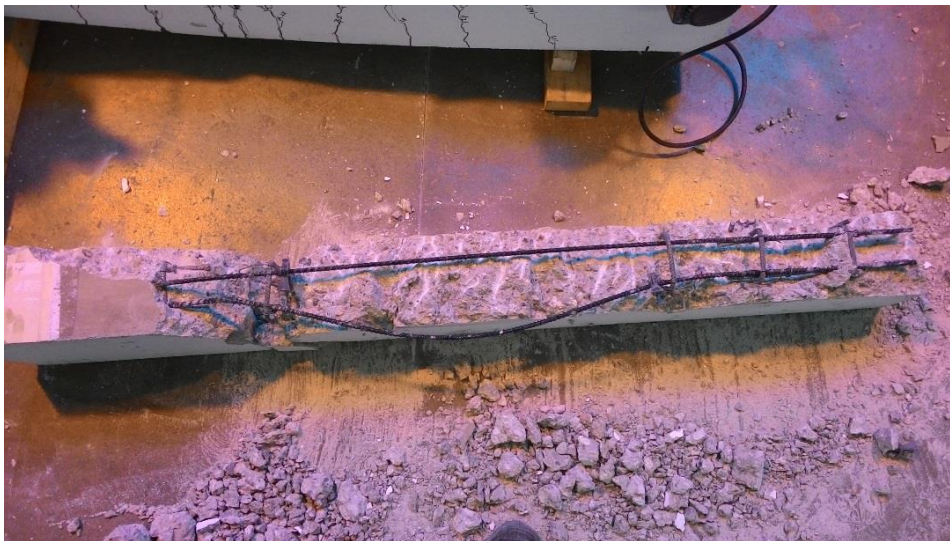
Photo 9:Bottom basalt rebar elongated.

Further investigation revealed that one out of two longitudinal BFRP tension reinforcing bars “snapped”. However, the second rebar did not “snap”. Instead it went through significant elongation as illustrated in Photo 9 and Photo 11.

It is important to address the fact that one of the basalt longitudinal bar underwent significant elongation only at the point of failure as depicted in Photo 9. It was initially assumed that the slippage of the BFRP rebar (located at the tension zone) occurred. The slippage phenomenon means that the BFRP rebar is moving irrespective of the concrete surrounding the rebar. However, subsequent full exposure of bottom basalt longitudinal bars showed that slippage did not occur that could be detected by a visual inspection, as there was no evidence of rebar slipping. This suggests that once the first basalt bottom longitudinal bar “snapped” full load applied by the experimental machinery was transferred onto the second basalt bottom rebar. At this point rebar was carrying the load which was twice the load the rebar was designed to carry. This dramatic elongation can be explained by the high Poisson’s ratio. It was established by Gohnert, Gool & Benjamin (2014) that Poisson’s ratio is approximately 4 (subject to variation depending on manufacturer) as opposed to steel with ratio of 0.25-0.3. This means that basalt reinforcement can go through significant elongation which results in reduction of the cross-sectional area compared to traditional steel reinforcing rebar.

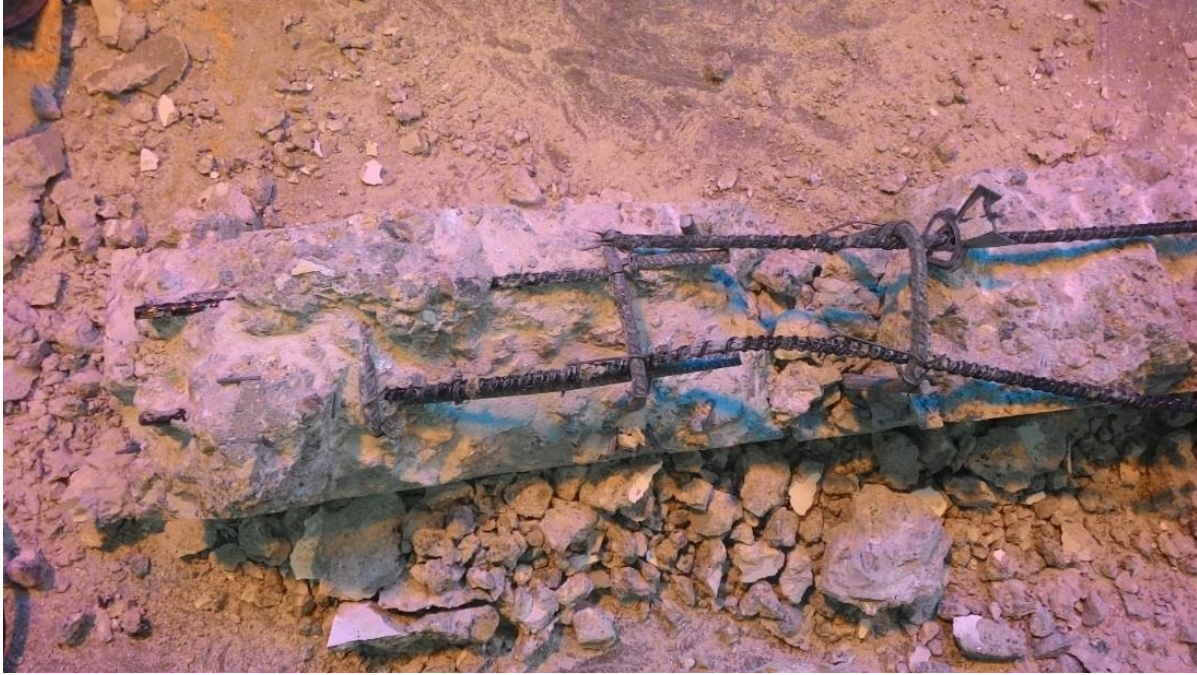
Photo 10:Basalt B2: bottom face of the beam.

Finally, full concrete removal from the bottom face showed that no significant slippage occurred, that could be detected by visual inspection, as illustrated in Photo 10.

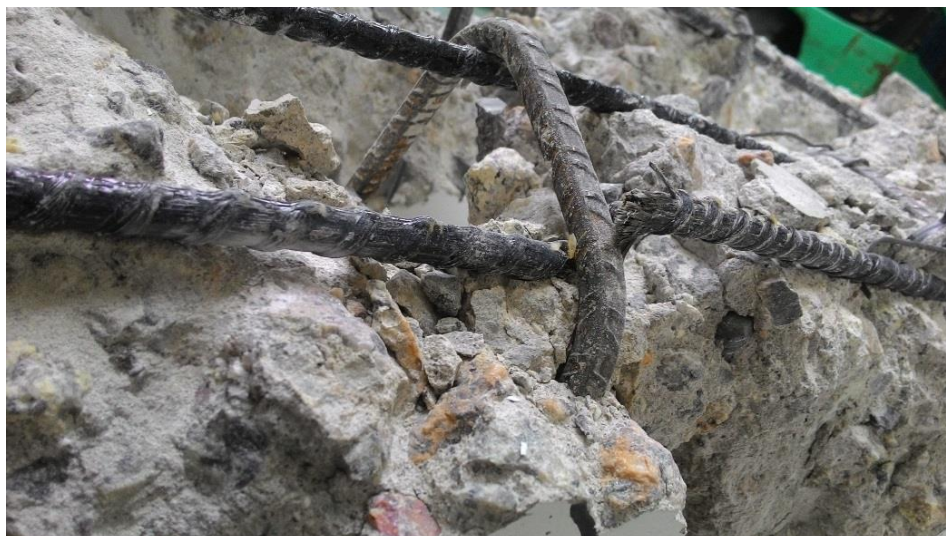
Photo 12: Beam B3 Reinforcement Failure.

The same procedure of visual inspection was carried out for basalt beam B3 and it was observed that one bottom bar “snapped” at the conjunction with the steel shear link as illustrated in Photo 12.

Similar results were observed when BFRP rebar reinforcement was exposed. Photo 12 shows that only one BFRP tension rebar “snapped”. BFRP rebar failure occurred at the conjunction with the steel shear link, suggesting the failure was caused by the steel shear link.

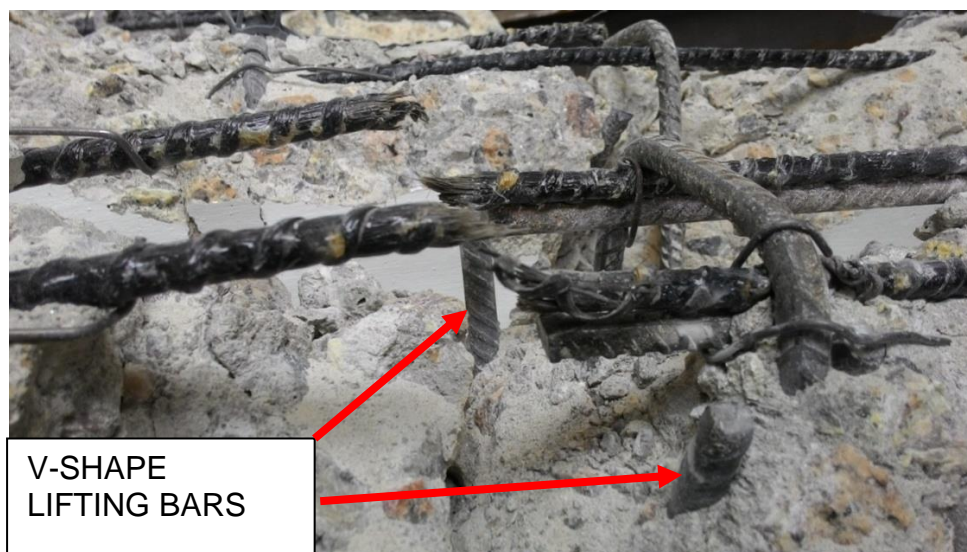
Photo 13: Beam B4 Reinforcement Failure.

Visual inspection showed that the both BFRP tension bars “snapped” in beam B4. Failure of the basalt beams occurred at the “shear crack” propagation point. The failed basalt bars did not exhibit significant elongation before failure as opposed to beam 2 as outlined in section 4.3.

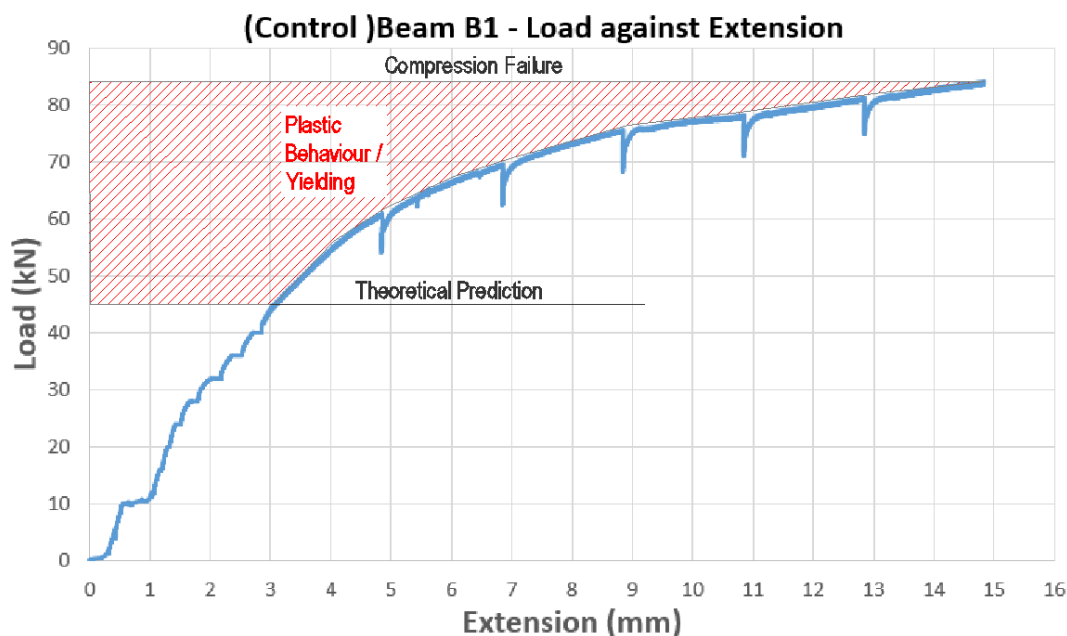
Figure 5: Steel Bar Yielding.

Failure load summary in Table 1 shows significant difference between beam B1 theoretical and experimental failure load values. Traditional steel reinforcement design principles outlined in the appendix **Error! Reference source not found.** calculates the failure load up to the plastic limit when steel bars start to yield. This explains the experimental failure load being over 46% higher than predicted. When tension bar reinforcement reached plastic behaviour, it was still able to accommodate increase in load by the means of yielding (refer to Figure 5).

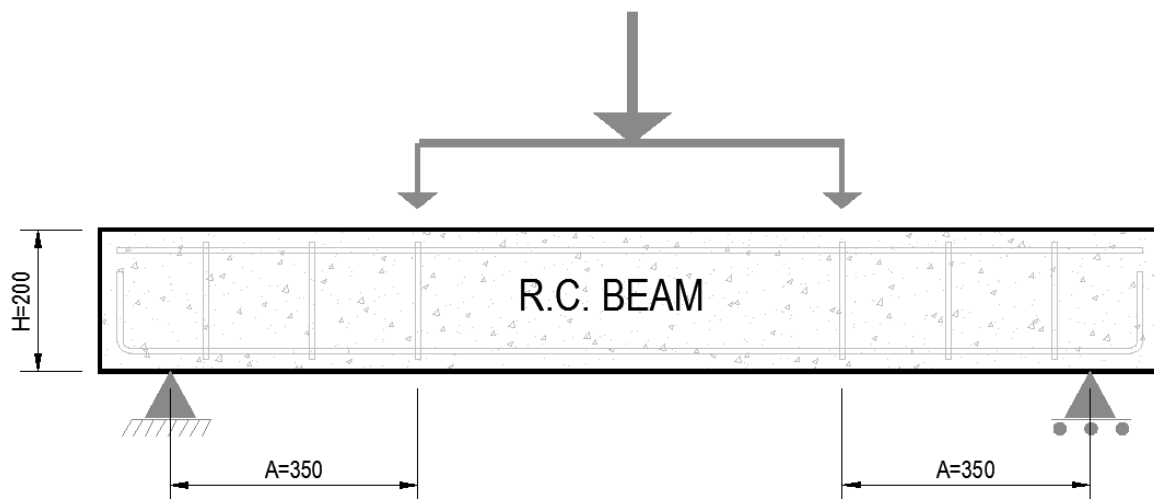
Figure 7: Shear Span Ratio of the Reinforced Concrete Beams.

$$\text{SHEAR SPAN RATIO} = \frac{A}{H} = \frac{355}{200} = 1.8$$

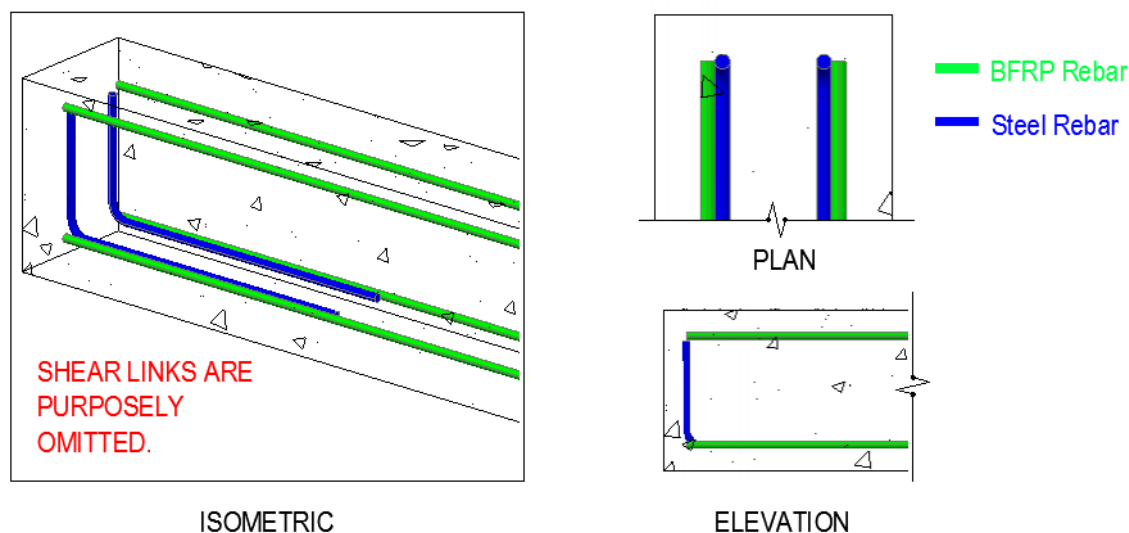
Figure 8: Steel L-Bar Location.

To avoid the failure of BFRP rebar described in section 6.4.4, further improvement could be made by placing steel L bars to the side of the BFRP longitudinal tensions bars (refer to Figure 8).
