# Investigation into the process of cured-in-place pipe sewer rehabilitation

Caitlin Mitchell

*Project Advisor: [Tony Tapp](#), School of Engineering, Computing and Mathematics, University of Plymouth, Drake Circus, Plymouth, PL4 8AA*

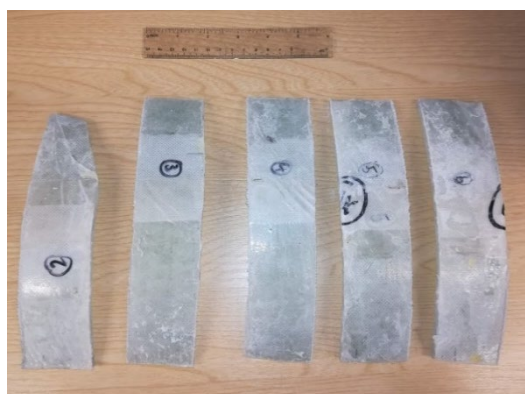
**Figure 1:** Batch C samples longitudinal view.

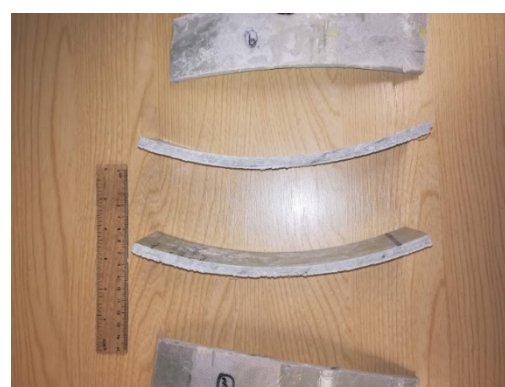
**Figure 2:** Batch C samples prior to testing. Plan

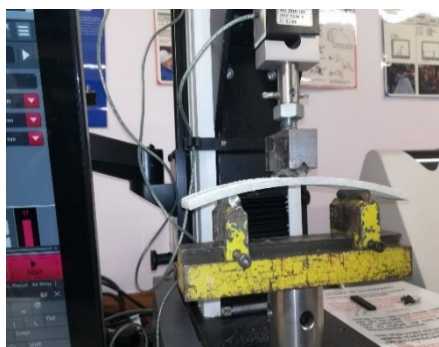
**Figure 3:** Flexural strength, 3-point bending test set-up.

- 1) The 3-point bending test machine was calibrated, and a span set based on the length of the sample. Sample span can be found in table 5.
- 2) Samples can be inputted into the machine, as shown in figures 3 and 4.
- 3) The applied force load cell was lowered to sit on the sample.
- 4) A load of 10mm/min was set, following guidance from ISO 178:2010+A1:2013.
- 5) All appropriate data regarding the sample sizes etc., was inputted into the testing machine.
- 6) The machine was the balanced, calibrated to 0 throughout.
- 7) Load was applied at the set load, strain (%) and displacement (mm) were recorded and a Young's Modulus was calculated.

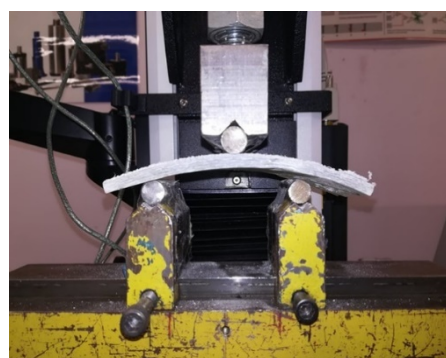
**Figure 4:** Flexural strength, 3-point bending test set-up.

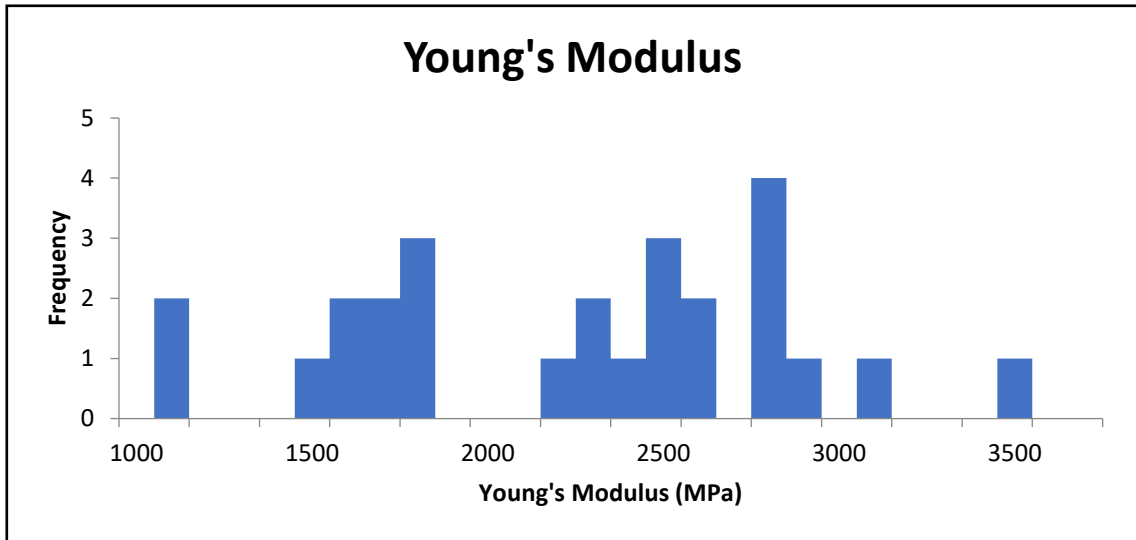
Figure 5 shows the frequency of Young's Modulus values across all samples. Full batch breakdowns of the Young's Modulus can be found in appendix 2.

Figure 5: Young's Modulus Histogram

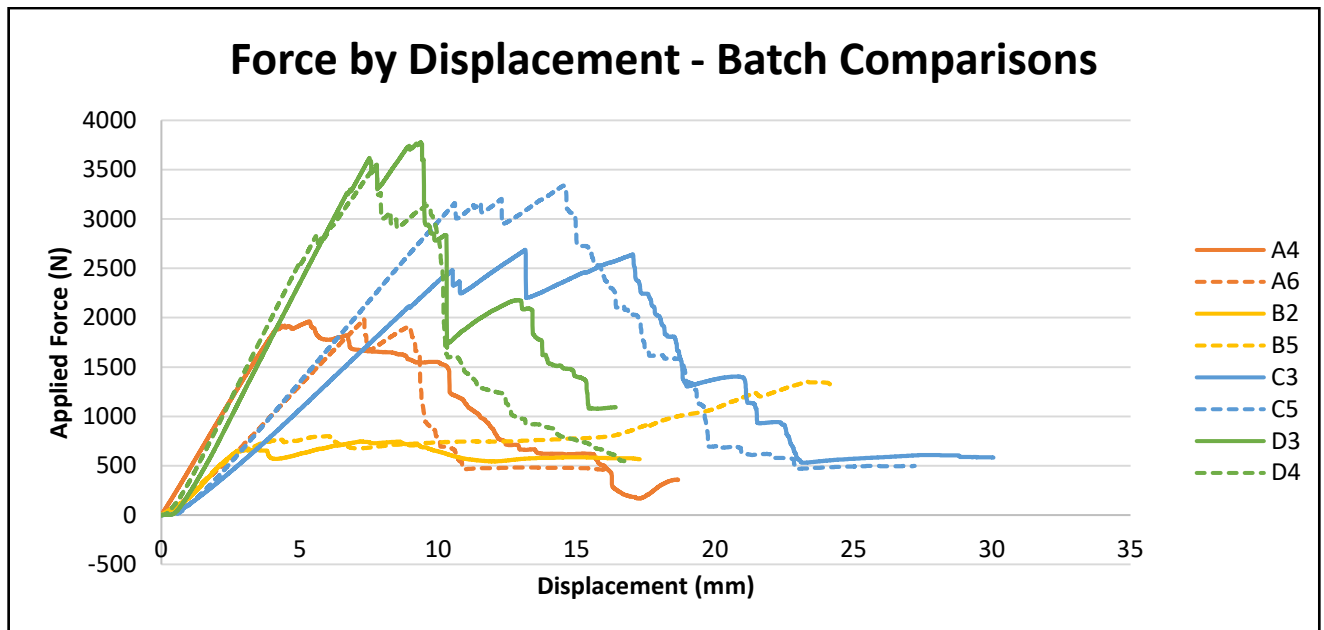
Figure 6 shows a range of 2 samples from each batch of testing completed and the associated displacement displayed. This has been created to quickly compare different batches of testing without cluttering the graph. Full graphs for each batch can be found in appendix 3.

Figure 6: Force by displacement - batch comparison

model which would be expected in a composite matrix, carrier material (shown in figure 6). Whereas it is difficult to see the actual failure point of batch B due to the ductility of the failure (see figure 6 and appendix figure 3B). The maximum displacement also ranged dramatically throughout the varying samples, appearing to level out at roughly 12, 20, 25 and 16mm for batches A, B, C and D respectively. Which shows a considerable range, once again batch B showed variation from the other samples and even at 20mm deflection the sample hadn't reached its maximum, showing it could potentially keep deflecting under heavier loading.

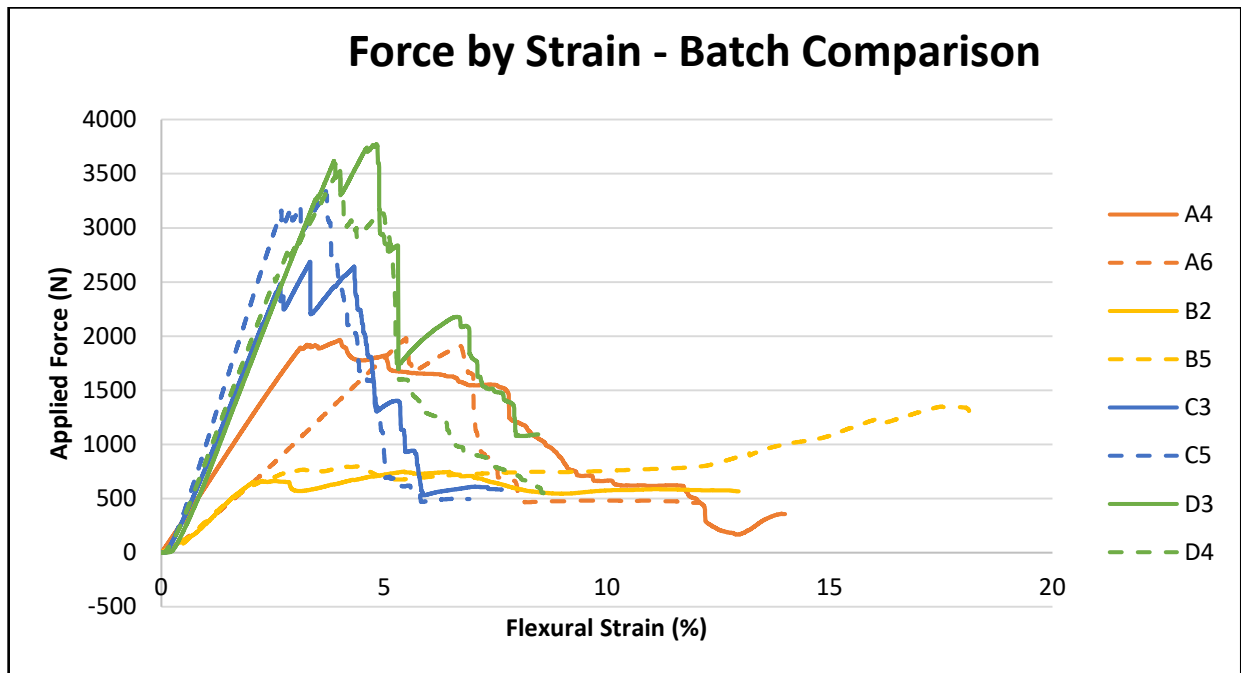
Figure 7 is showing the same style of batch comparison but comparing the applied force with the flexural strain (%). Full batch graphs can be found in appendix 4.

Figure 7: Force by strain - batch comparison

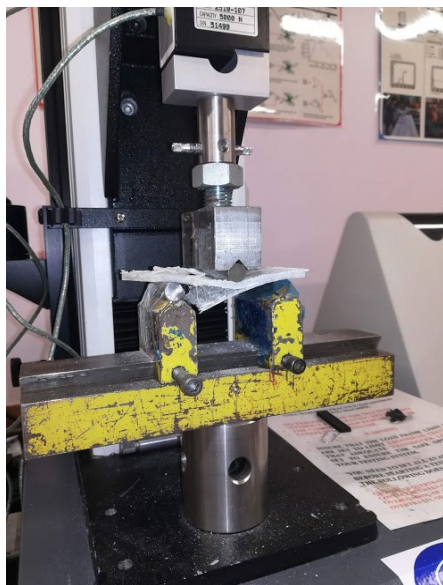
As shown in figure 8, the expected form of failure would be delamination, which cause vulnerable areas more susceptible to other defects. The 3 batches (A, C & D) all failed with delamination as their clear behaviour showing similar graph shapes, even though their first break point is varying, they show a very clear first break point and deflection

Figure 8: Batch A testing behaviour.

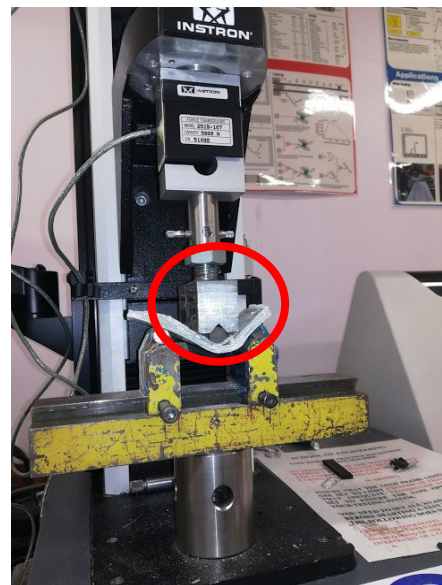
Batch B is considerably different in behaviour than the 3 other batches, having a much lower maximum applied force. When being tested, batch B behaved differently in failure also, failing with high ductility and almost no external delamination present on many of the samples' surfaces, as shown in figure 9. This caused a slight change in the properties of the test, as the edges of the point load applicator (shown in a red circle in figure 9) were touching the sample, changing the loading from a single point load to a 3-point load acting more in a uniformly distributed load format. The lack of delamination and the elastic behaviour could show that the sample hasn't been fully cured compared to the other samples. After the testing of batch B, the samples returned almost to their original shape.

Figure 9: Batch B testing behaviour.

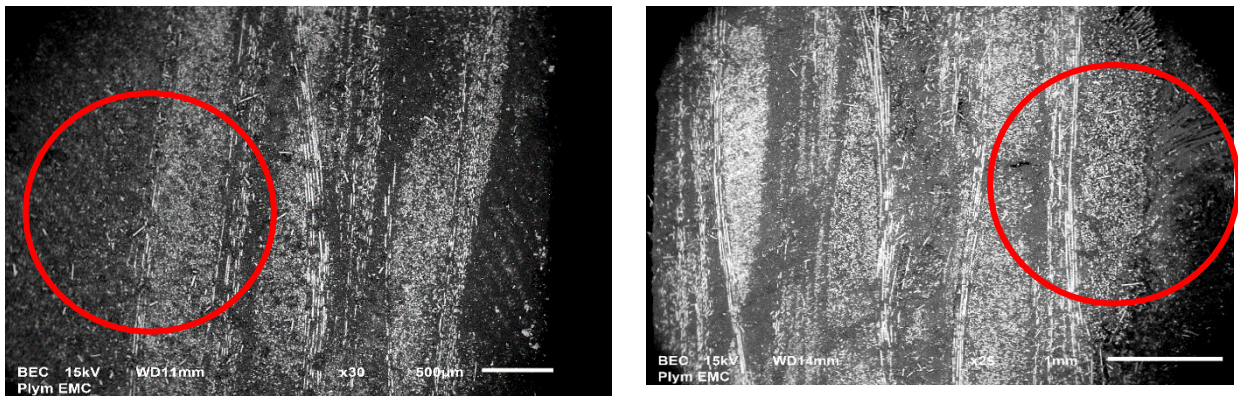
Figure 10, representing a sample taken from batch A shows a distinct lack of fibres at the edges of the sample which could contribute to the brittle nature of the failure observed during testing. However, figure 12 and 13, show a more varied spread of fibres and they also exhibited a brittle delaminating form of failure.

Figure 11, representing batch B, showed an overall good coverage of fibres throughout the width of the sample with a lack of voids present (large black areas without fibres). The connection with the fibre spread and form of failure could be studied further to investigate the connections through a larger number of samples. Figure 9 showed

Figure 10 & 11: Sample A - whole thickness (L), Sample B – whole thickness (R)

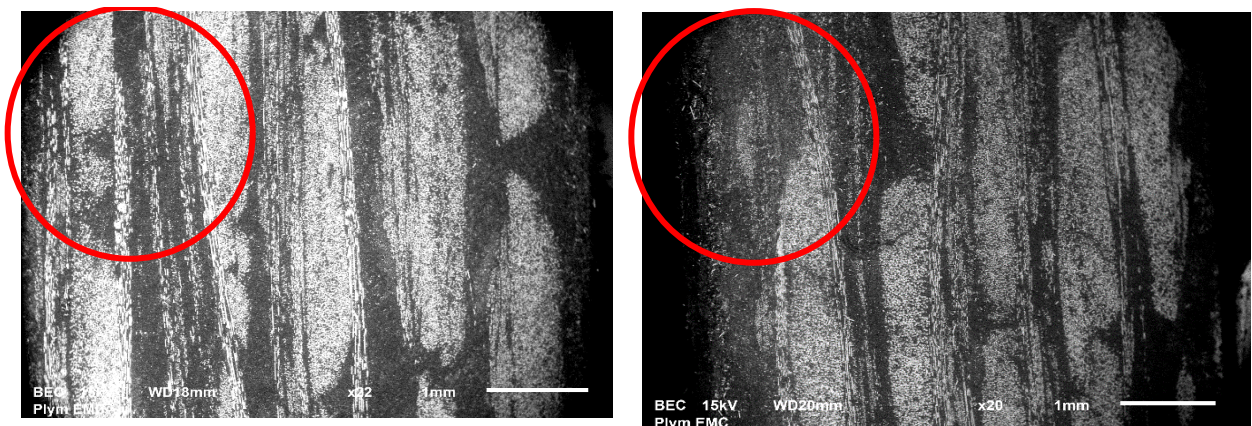
Figure 12 & 13: Sample C - whole thickness (L), Sample D – whole thickness (R)

some voids present throughout sample C, but overall the sample indicated a good spread of fibres, reaching to the edges of the sample. Sample D, shown in figure 13
