Wolf Rock Lighthouse Long-Term Monitoring

Article

Abstract: Wolf Rock Lighthouse is a Victorian era masonry structure located in an extreme environment facing the fiercest Atlantic storms off the southwest coast of England whose dynamic behaviour has been studied since 2016. Initially, a modal test was used to determine modal parameters; then, in 2017, a monitoring system was installed that has operated intermittently providing response data for a number of characteristic loading events. These events have included wave loads due to storms, a small UK earthquake, helicopters landing on the helideck, and the grounding of a ship on the reef. This is believed to be the most extensive experimental campaign on any structure of this type. This paper briefly describes a unique project involving the characterisation and measurement of dynamic behaviour due to different forms of dynamic loading.

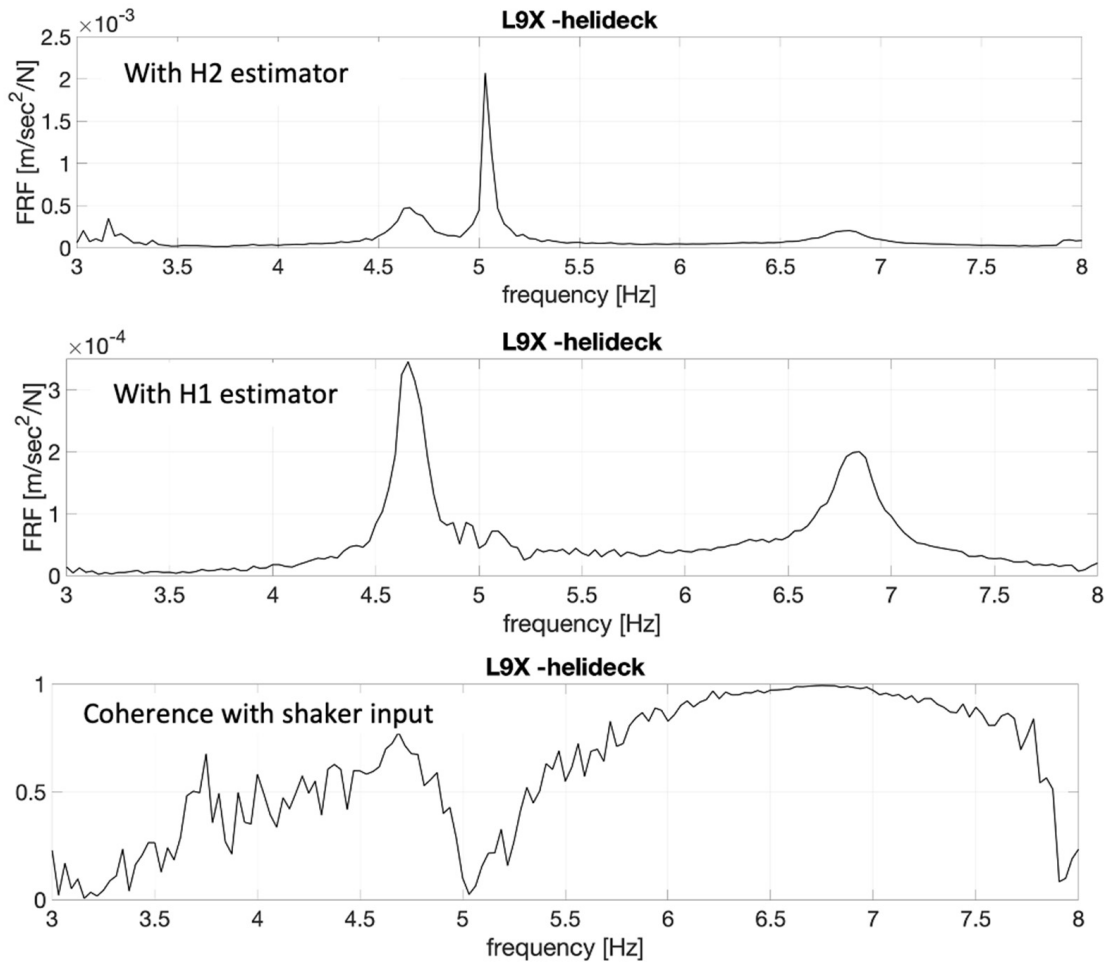
Figure 4. FRFs between helideck (L9) and shaker in x-direction (run18) using H2 FRF estimator (upper), H1 estimator (middle), and coherence function (lower).

Frequency response functions obtained using the shaker are examined in Figure 4 using both types of frequency response function (FRF) estimator, i.e., ‘H1’ and ‘H2’ [21], which are, respectively, appropriate when ‘noise’ appears/does not appear on the response signal. The coherence function in the lower plot shows the 5.1 Hz signal appearing closer to 5 Hz uncorrelated with the shaker (input), and the peak disappears when using the H1 FRF estimator; hence, it is purely a helideck mode with zero involvement of the tower.

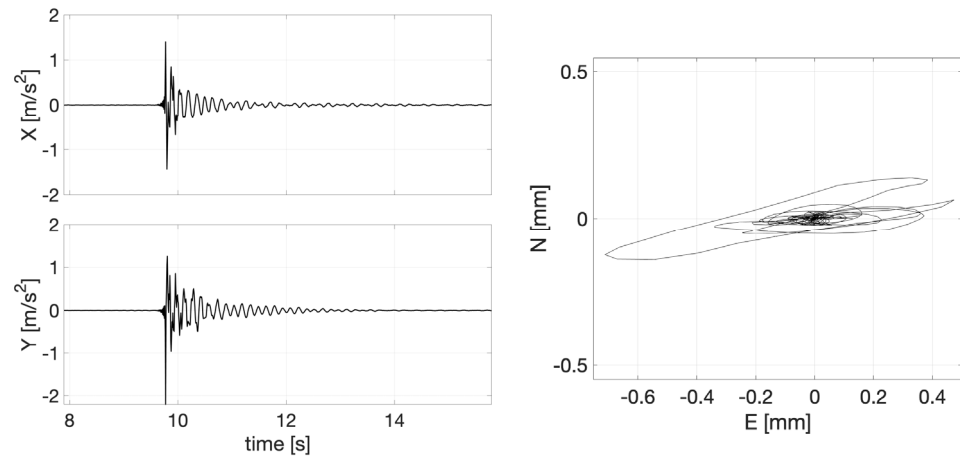
Figure 11. Response to wave impact during Storm Brian as acceleration and displacement trajectory.

During the monitoring period with available data, several storm events were captured, the majority named by the UK Meteorological Office, others named by the USA (Ophelia), Portugal (Diana, Irene), or France (Matthis). The strongest recorded acceleration was during Storm Brian which reached 2.6 m/s^2 , (Figure 11) corresponding to 0.7 mm level 7 displacement aligned south of west, consistent with prevailing wind (hence breaking wave) direction.

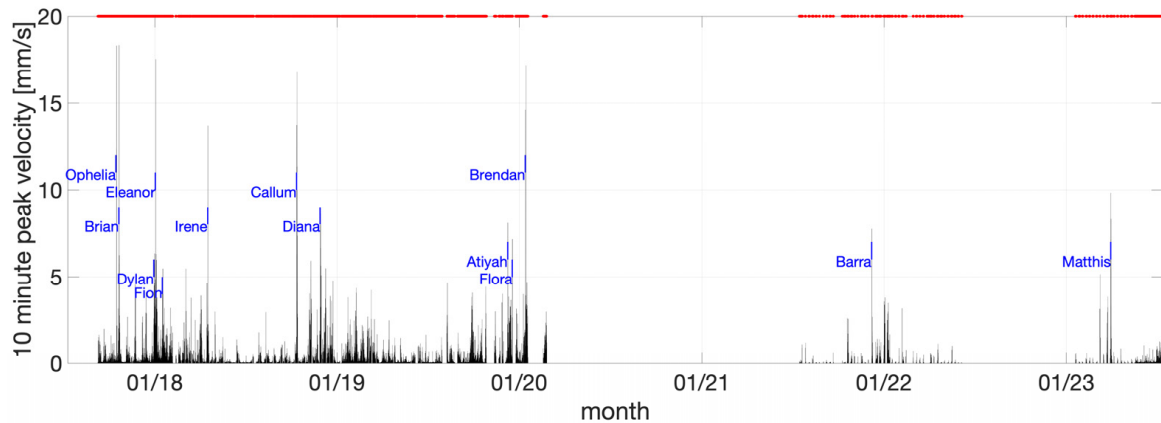
Figure 12. Recorded battery room peak velocities. Red dots indicate available data.

Figure 12 shows peak 10 min velocities over five storm seasons (much of 2020/21 was missed due to COVID-19). Rather than taking accelerations for the strongest wave impacts, peak velocities obtained from the vector sum of integrated level 7 accelerations are shown as they directly indicate wave loads. This is due to the impulsive nature of the response (evident in Figure 10) via the relationship of known modal mass and change of velocity (the indicated peak values) to wave force \times duration.

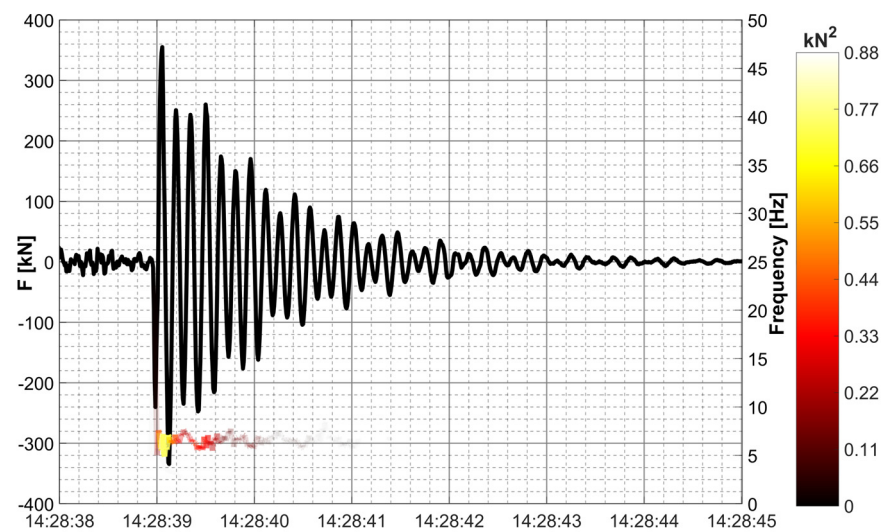
Figure 13. Inertia force based on acceleration signal and modal mass and instantaneous frequency.

This information has been used to estimate the wave forces experienced due to breaking waves for ex-Hurricane Ophelia. The inertia force of an exemplar extreme wave impact (envisaged via the modal mass for unity mode shape at level 7) is shown in Figure 13. Via the Bayesian inverse identification process described in [25], the response corresponds to a peak force of 7 MN if applied as a breaking wave impact 7.15 m above the tower base and with the strongest part, a double-peak impulsive component lasting 0.06 s. In fact, knowledge of the point of wave impact is not known and is one objective of the video system now in operation.

It is the impulse (integration of force with respect to time) that delivers the change in momentum observed as velocity change via the data acquisition system, with the duration of the wave impact being a fraction of a second. If the response is a linear elastic vibration, the impulse can be estimated via modal mass and the peak modal velocity due to the impulse.

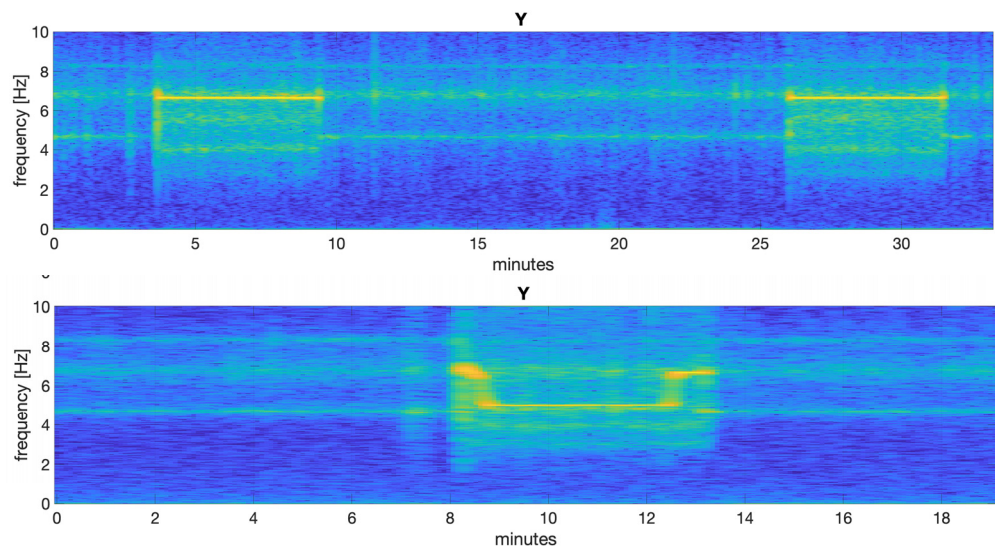
Figure 15. Spectrograms of level 7 response for helicopter visits in 2020 (upper) and 2019 (lower).

Two occasions are shown in Figure 15. The first is for the afternoon of 6 January 2020 when the same helicopter made two visits to ferry workers from the lighthouse to Land’s End (St Just) airport, a distance of approximately 20 km. There is a strong steady state signal around 0.03 m/s^2 with an amplitude of 6.65 Hz. This is consistent with other known helicopter visits. The second occasion is during the ambient 2019 vibration survey (for which simultaneous monitoring data are not available) showing three periods: a steady 5.02 Hz period between two short periods of vibration, first at 6.66 Hz then at 6.69 Hz. This appears to be a unique recording (among all the monitoring data). The higher frequency corresponds to ~ 400 (rotor) RPM observed using video recording of the aircraft landing at the lighthouse, while the lower frequency corresponds to ~ 300 RPM observed from audio recording of the aircraft (idling) on the ground at Land’s End Airport.

The upper and lower frequencies correspond closely to the 5.01–5.1 Hz mode evident from 2016 ambient response (Figure 3) and the 6.73 Hz and 6.77 Hz estimates obtained from the 2019 ambient response (Figure 8). The forcing function due to the rotors at both full and idling speeds is apparently close enough to mode frequencies to cause resonant amplification.

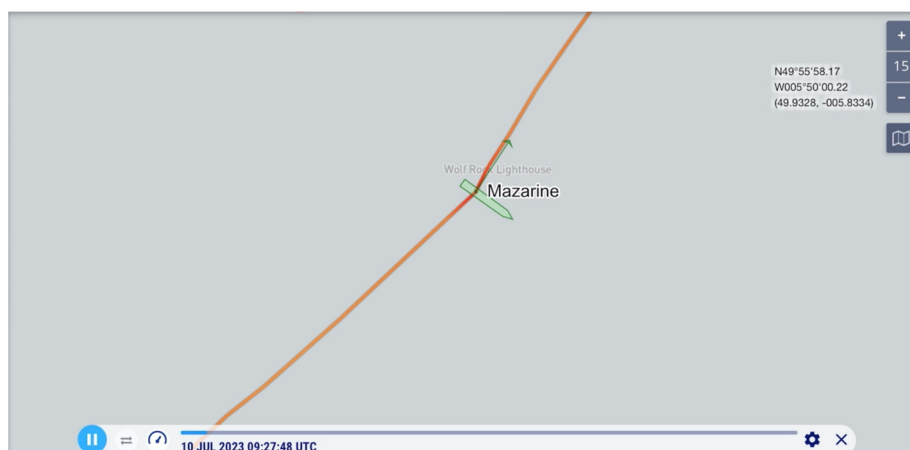
Figure 18. Trajectory of Mazarine, indicating grounding at 09:27.

On 10 July 2023, the RoRo cargo ship Mazarine, enroute from Ireland to Belgium, lost power and drifted onto the reef of Wolf Rock. Marine tracking shows that the grounding occurred at 09:27 UTC (10:27 local time). The tide was still rising at the time (high tide at 10:00 UTC) and the ship rotated around the stern, resuming a drift towards the Cornish coast at 09:50 (Figure 18).

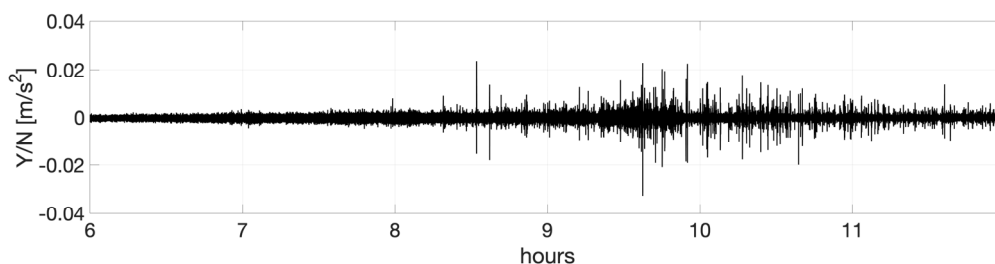
Figure 19. Acceleration response between 6 A.M. and 12 noon, 10 July 2023.

The y/north acceleration for the period from 6 A.M. to noon is shown in Figure 19 and features typical breaking-wave impacts (for a relatively windy summer day) but no evidence of the ship directly impacting the structure.
